SERVICE BULLETIN No. L13/002

Subject: Locking of the rudder control cable against release.

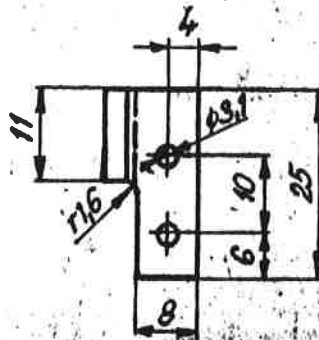
Figure No. 1

Reason: Original arrangement was not safe against falling down of the cable from pulley.

Description: Attachment of two brackets to the rudder rib No.1 to prevent falling of the cable from pulley.

1. Tilt the horizontal stabilizer.
2. Disassemble the rudder control cable at the front pedals and remove the rudder.
3. Position the bracket to Fig.2, make a thread M3 and attach by 4 bolts M3.
4. Reinstall the rudder and control cables to the front pedals.
