## MANDATORY BULLETIN No. L 33/002a

**Effectivity:** The L 33 sailplanes S/Nos. 930101, 930102, 930105, 930106.

**Reason:** Modification of the sailplanes to standard design for the USA.

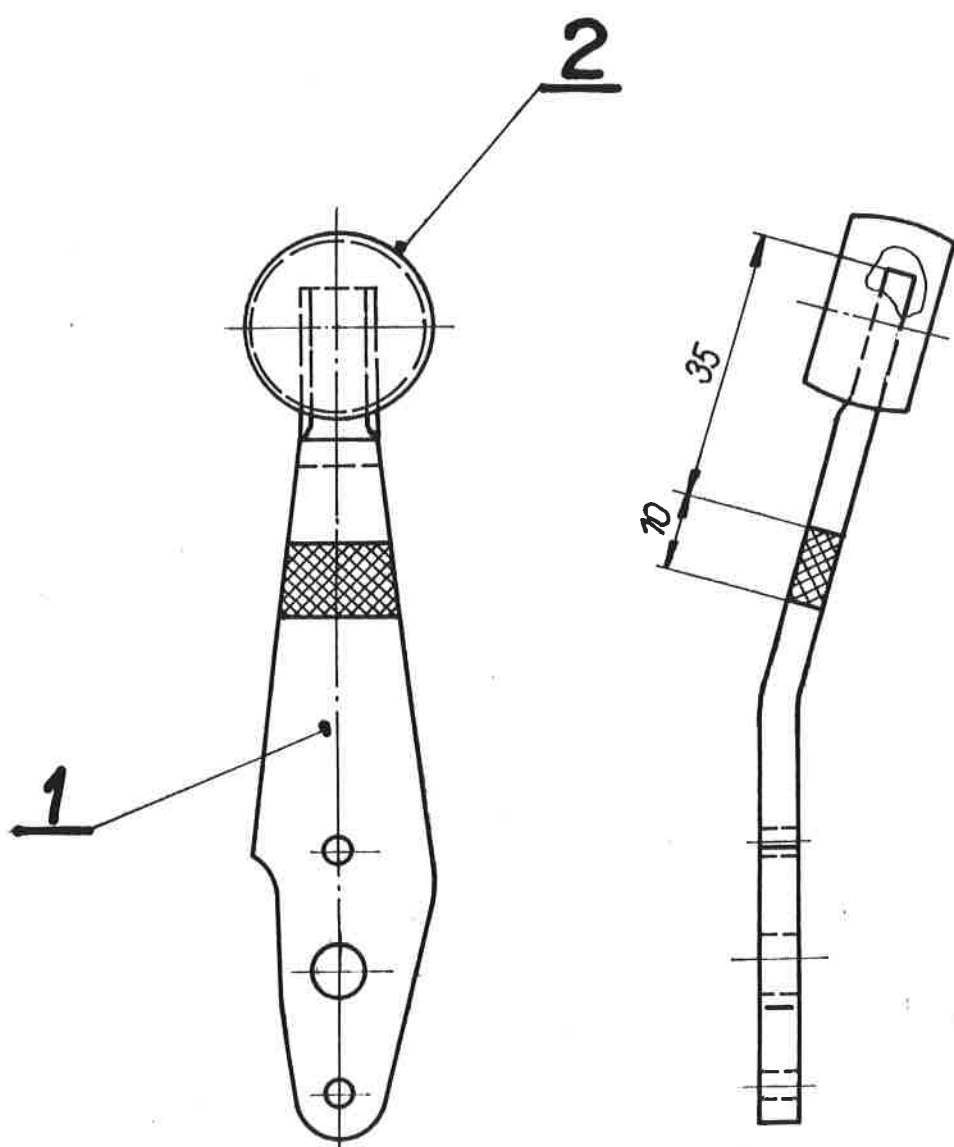
### 1. Replacement of handle of the canopy operating lever (Fig. 1.7)

- Fig. 1 - Canopy operating lever with dimension figures for lever arm marking.
- Fig. 2 - Sketch showing the location of datum point on the sailplane nose section.

- 1.4. Remove the bits of adhesive from the contact surface of the handle (pos. 2) on the lever (pos. 1).
- 1.5. Measure 35 mm from the edge of the lever, degrease the lever with a solvent and mark it with a red strip 10 mm wide. Apply a coat of S 2003 primer and, after a period of 3 hours, a coat of C 2001/8140 top.

- 1.7. Put a white handle (pos. 2) on the lever (pos. 1). The setting time of the adhesive is 24 hours minimum at 18 C to 25 C. Set the lever in such a position that the adhesive may not flow out before it is set.

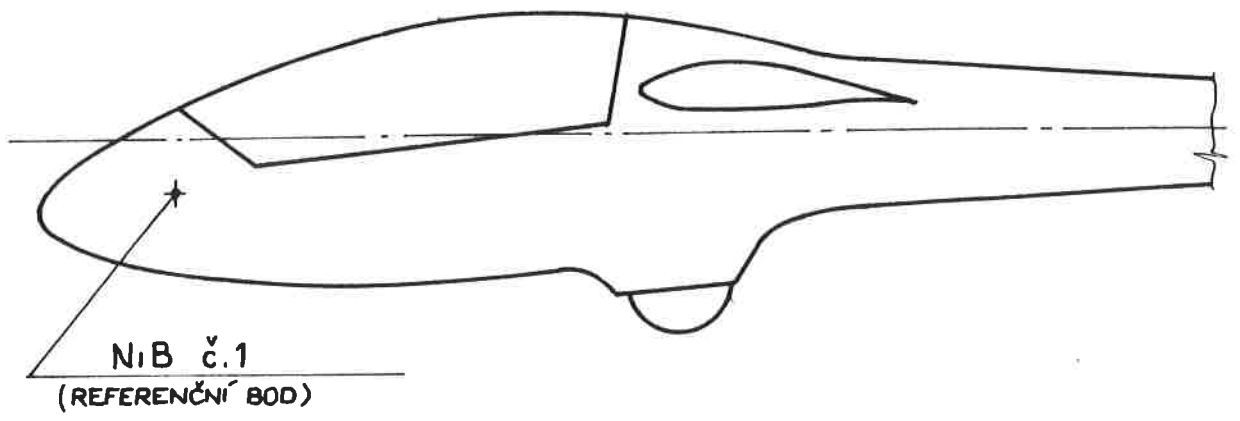
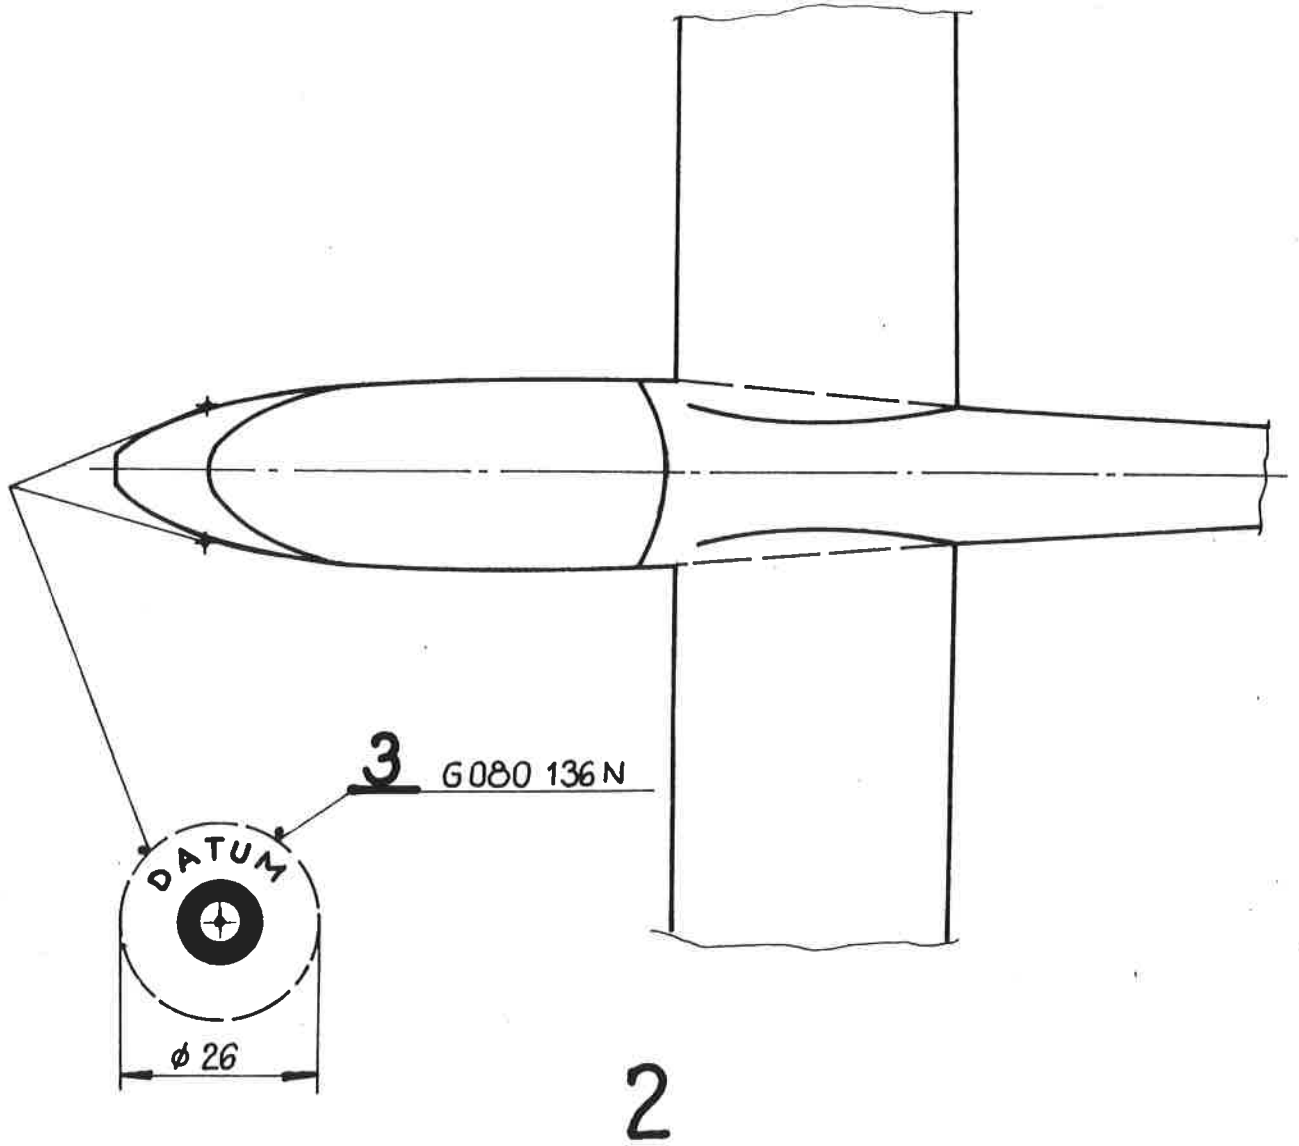
### 3. Marking of datum point (levelling point No. 1) on both sides of the sailplane nose section (see Fig. 2)

- 3.1. Stick a label (pos. 3) with the word "DATUM" round the levelling point No. 1 on both sides of the sailplane nose section as shown on Fig. 2. The label must be located so that the levelling point is in the centre of the red-colour disk.
