SERVICE BULLETIN No. L13/004

Subject: Rear fuselage section of the L13 a/c

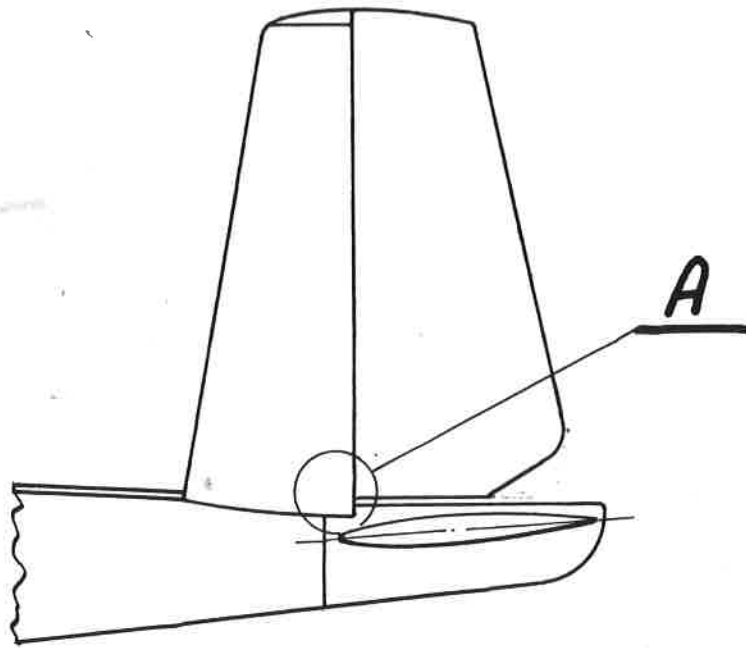
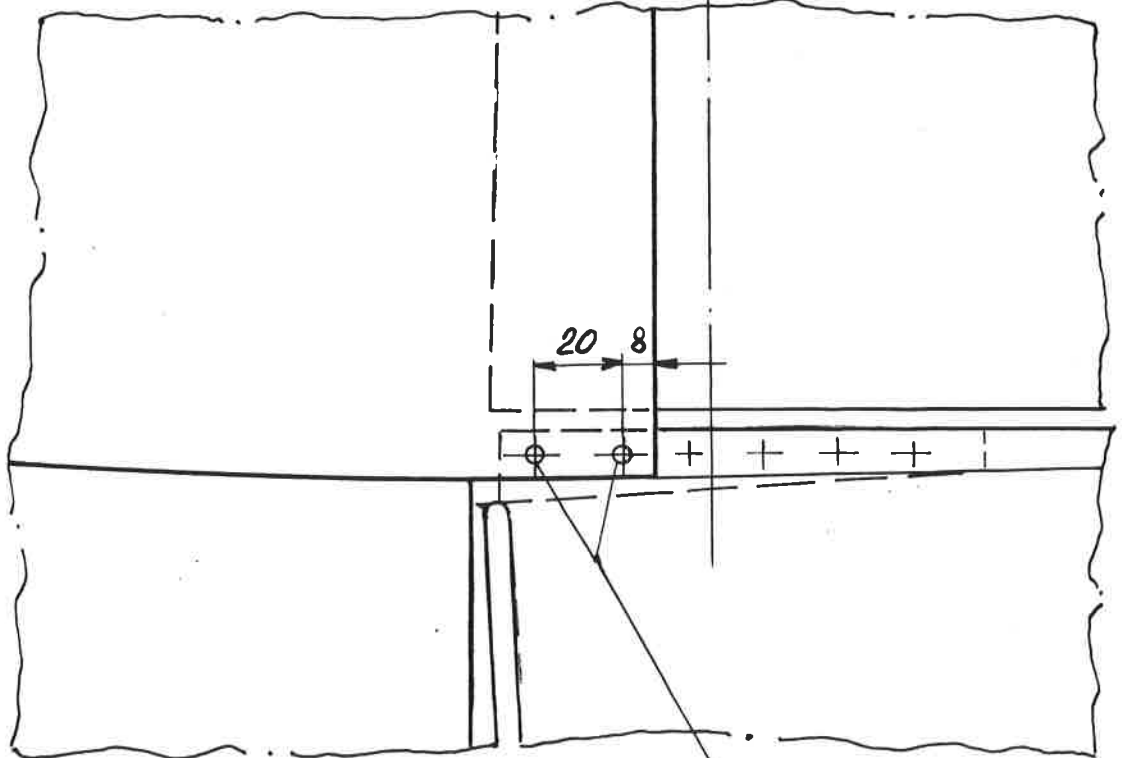
Det. A

Reason: Cracking of the rear fuselage skin panel within the joint gap between stabilizer hinge and frame No. 14, due to fatigue.

5DuV 2,6x6 P
4 ks. na stroj.

1. Mark and drill two holes dia 2.7mm in the fin skin and rear fuselage on either side to Fig.1, det.view A (shortest length of the rivet centres from the edge is 5mm)
2. Install the rivets into the drilled holes with their heads from outside the fuselage and attach the skin panel by rivetting.
