SERVICE BULLETIN No. L 13/016

Subject: Brakes in undercarriage wheel installed on L 13 sailplane 1st through 22nd series.

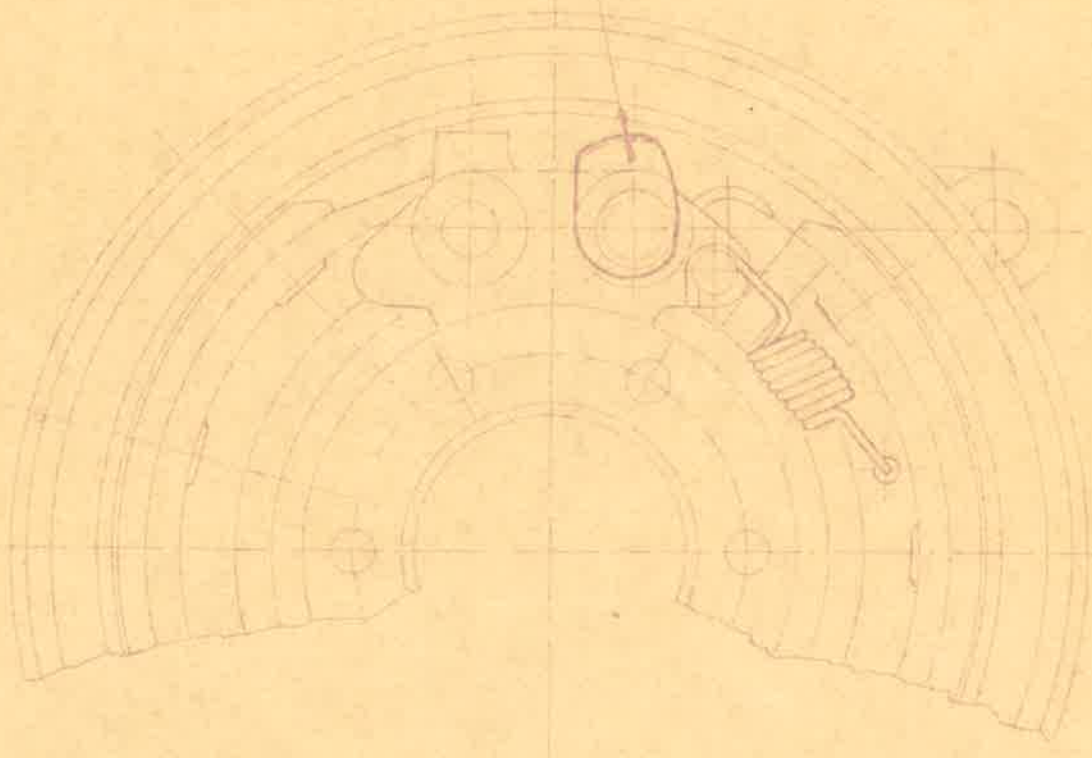
1

Reason: Jamming of cam against working surface of the brake drum when the brake is used excessively in service.

Jack the sailplane and lower the undercarriage. Remove a shield complete with brake. Release the cotter-pin in operating shaft, take out this shaft and remove the cam. Then hold the cam in hands and grind off .3 to .5mm in accordance with Fig. 1. Assembly is carried out in reverse procedure and component greased using a vaseline.
