LET národní podnik KUNOVICE

OPERATING BULLETIN No. L 13/025

**Re:** Inspection and eventual replacement of control rods eyes on the sailplane L 13 - from the 1st series up to the 14th sailplane of the 34th series.

**Reason:** Danger of the eye breakage due to sharp edge recess made on it.

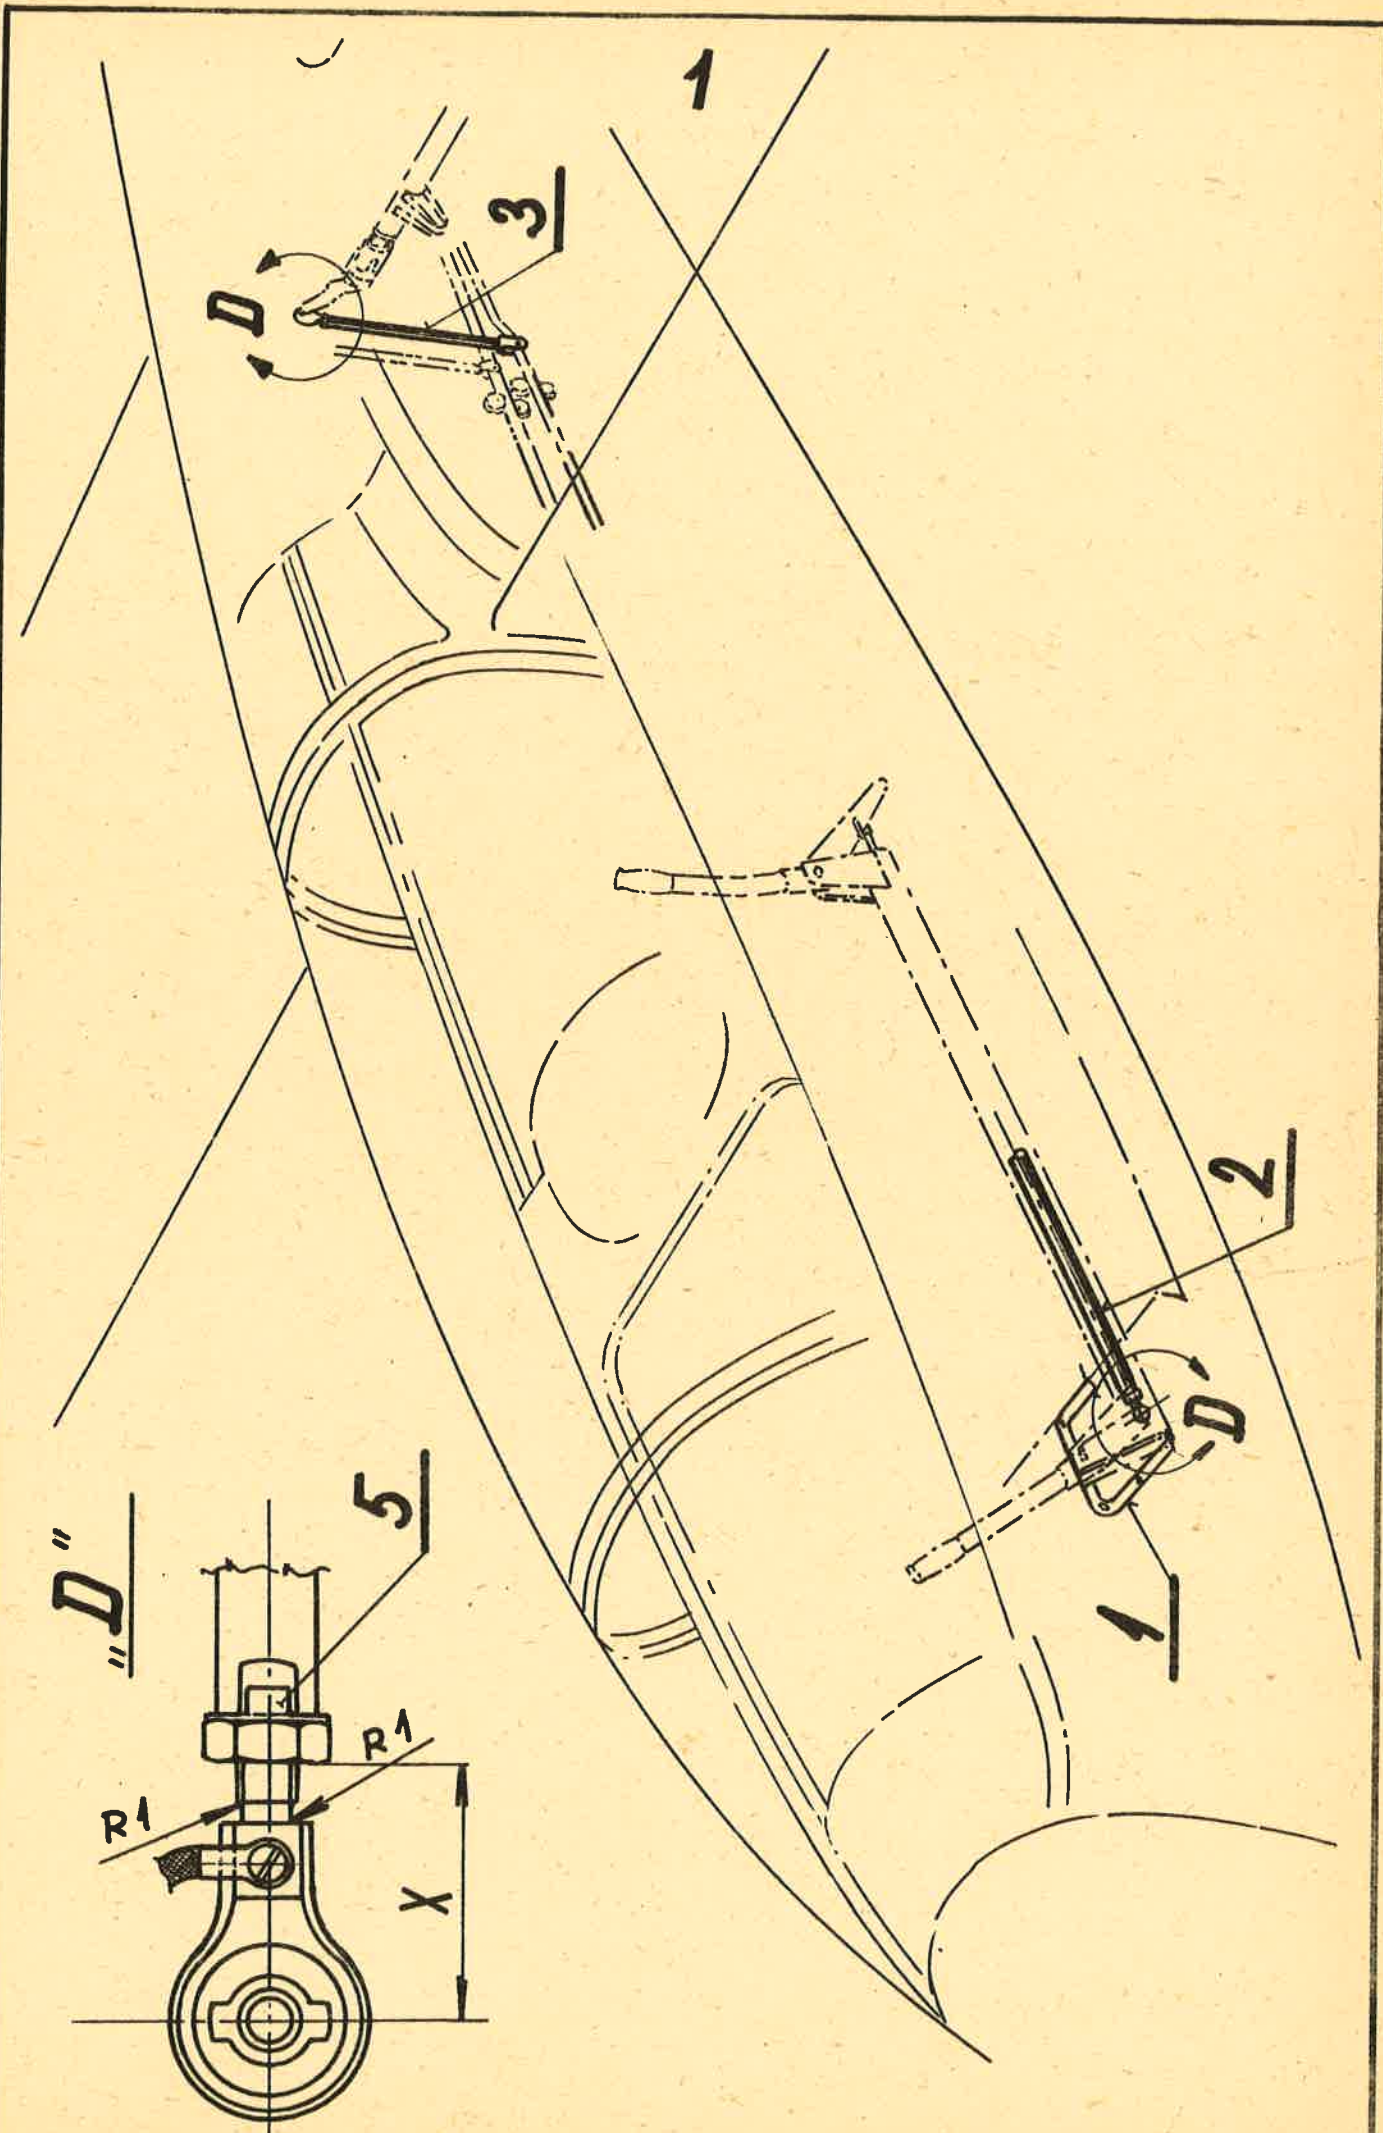
Remove the frame and the floor fabric cover of the front control stick (See pos. 1). Check the eye of connecting control rod (pos. 2), if the radii of recess on the eye corresponds to the radii R1, shown in detail on Figure "D". The same procedure is to be followed with the interceptor control rod in fuselage (pos. 3), and wings - near the rib No. 15 (See Figure 2, view "A", pos. 4).

If the eye is screwed to the stop so that the nut covers the recess, it is to be unscrewed from the rod and properly checked (partial eye turning might be sufficient for inspection, but with regard to the lock washer pos.5, Fig. 1, detail "D" which cannot be re-used, it is necessary to remove the eye completely).

Note: In order to avoid re-setting of control rods due to the inspection and replacement of eyes, it is recommended to measure the distance X, shown on the Fig.1, detail "D", and then screw and safeguard the replaced eyes accordingly.

Report to the Technical Service Dept. of the Manufacturer that will supply new eyes for replacement free of charge, if any of the radii is smaller than R1. Inspection and replacement may be carried-out by a semi-skilled worker of the Operator.
