OPERATING BULLETIN No. L 13/031 L E T národní podnik K U N O V I C E

> Sheet No.: 1 No. of Sheets: 3

The L 13 gliderP/Nos. 170101 up to 174730.

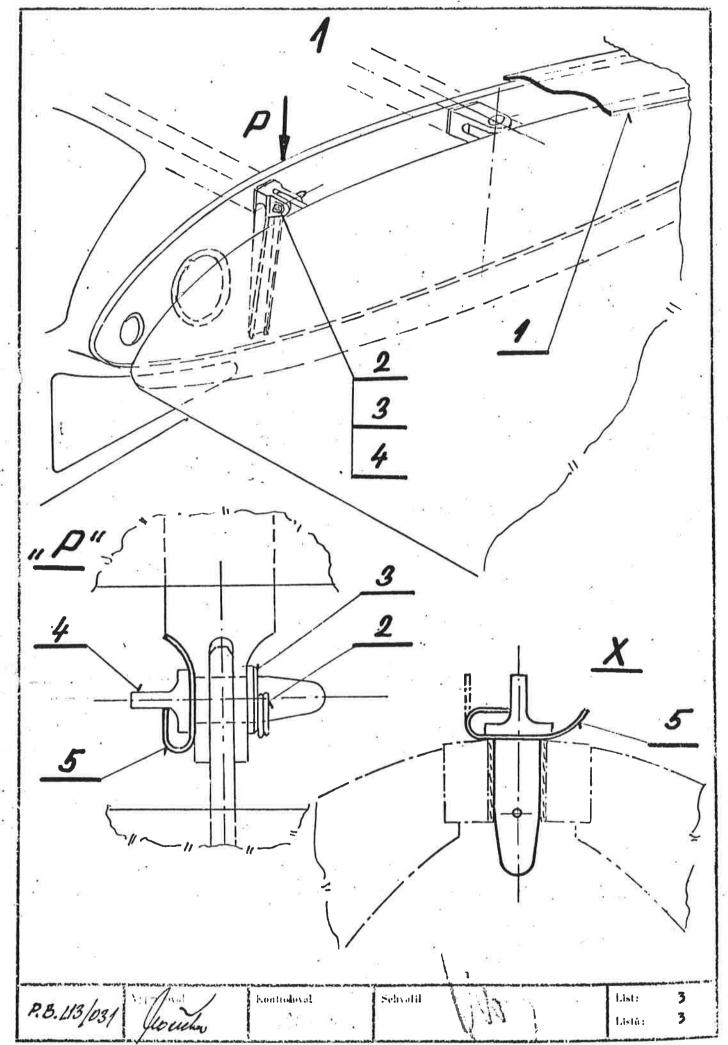
Angular displacement of the pins in the wing front bings can occur due to vibration, resulting in the release of the safety wire.

3. Slip the tab washer (pos.5) on the pin (pos.4) nad bend the end of the washer towards the head of the pin. This is to be done preferably in a vice with soft jaws (see fig.1, view X).

4. Insert the pin in the front tinge of the wing, with the

bent end in the half-round recess in the binge.

5. Slip on the washer (pos.3) and secure it with the safety wire (pos.2). In case that the tab washer (pos.5) does not match the recess, shape it so that it fits perfectly in the

6. Check for proper securing and mount the fairing (pos.1).
