OMNIPOL PRAHA ČESKOSLOVENSKO

MANDATORY BULLETIN

No. L 13/040

Vertical stabilizer of the L 13 Blaník sailplane up to PIN 174230. Effectivity:

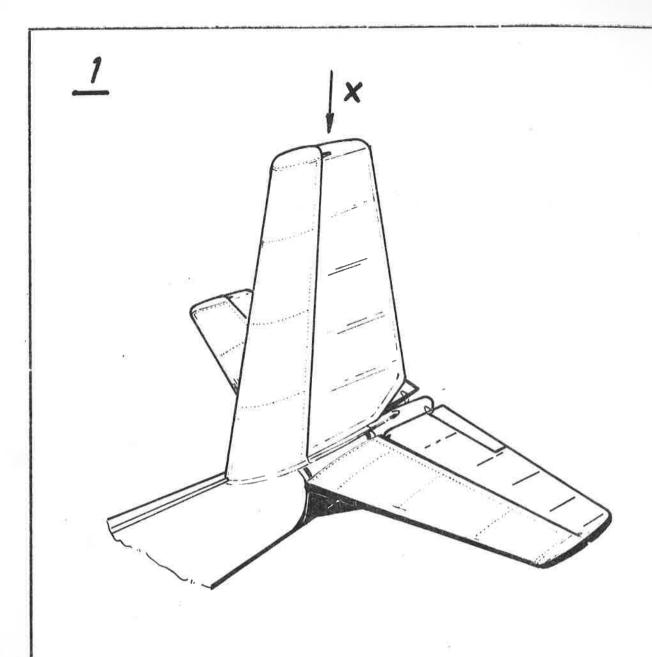
- MOTE: the sailplanes which were lately over hauled by the manufacturer may already have either or both modifications incorporated /a modification to the top rib is consistent with Figure 1, while the central stiffener is made of steel as against the former duralumin version/.

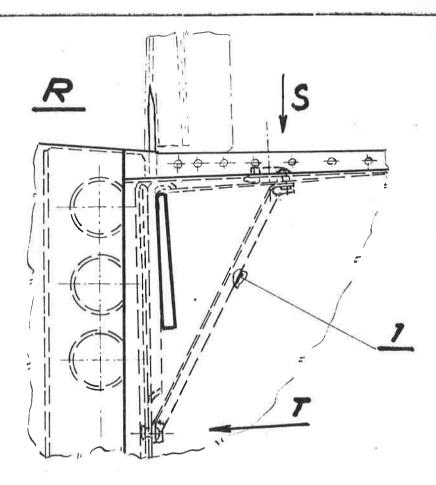
- 2. Swing the fuselage tail cone to check the central stiffener, which is designed to support the bottom mount of rudder /see Figure 2, item 1/, for cracks particularly near to the top edge. In case of crack propagation on this central stiffener as well as in case of a damage to the fin top rib it is necessary to follow the repair instructions as per the paragraph B. Should there appear cracks on the central stiffener with no damage to the fin top rib, the sailplane may continue to be operated subject to performing a repair as per the paragraphs B and D, within the maximum of 100 hours.

- 1. Remove the heads of two rear vertical rivets connecting the rudder mount /view S/, using a drill of dia. 3 mm /see Fig.2/.
- 2. Remove the heads of 3 bottom rivets, connecting the stiffener to a frame, using a drill of dia. 3 mm.

- 3. Install a new steel stiffener and mark the centres for rivets holes through the original holes up and down. Observe the minimum distance of 7 mm from an edge. Take out the stiffener and drill holes dia 2.6 mm as per markings.

- 4. Reinstall the stiffener into fuselage and a tach it on each side by means of screws. Drill the hole of dia. 3.1 mm.
 - 5. Safeguard the stiffener against any movements by inserting a rivet of 3 mm dia into the above hole. Then remove the mounting screws and drill the remaining holes dia. 3.1 mm.

- Take out the stiffener and thoroughly deburr all the openings in the stiffener as well as in the fuselage.
- 7. Reinstall the stiffener into the fuselage and attach successively through riveting.

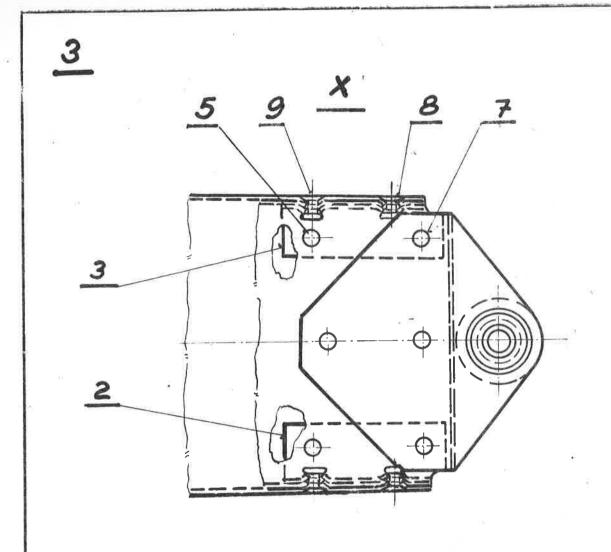
- Inspect the top rib of the fin within the rudder surface mount. Should any crack propagate as far as 5 mm, proceed with a repair as per instructions of the paragraph B below. If these cracks exceed 5 mm length, then replace the whole rib as per the paragraph C below.

- 1. Remove the two rivets on each side, connecting the skin panel, fin tip and the rib /see Figure 3/ using a drill dia. 2.5.
 Also remove the 2 extreme vertical rivets joining the rudder mount fitting and the fin rib using a drill dia. 3 mm.
- 2. Prevent further crack propagation /if the cracks are no longer than 5 mm/ by drilling a 2 mm hole at each end of the crack. Deburr these holes carefully.
- 3. Place two angles items 2 and 3 under the rib, mark the holes for rivets, drill a hole dia. 2.6 mm, recess this hole and then mark and drill the vertical holes according the original holes, using a drill dia. 3.1 mm.
- 4. Deburr the drilled holes thoroughly on both the angles and the fin.
- 5. Install both angles properly and attach by riveting.
