MANDATORY BULLETIN No. L 13/042

Effectivity: All L 13 Blanik gliders.

Reason: Inspections carried-out to determine the actual state of those gliders, which are nearing the established third overhaul time limit, result in lengthening the time before overhaul No. 3 depending on instructions outlined in this Bulletin.
The Bulletin contains detailed instructions on the Service Inspection Programme /see item 1/ and established Total Safe Service Life /see item C/.

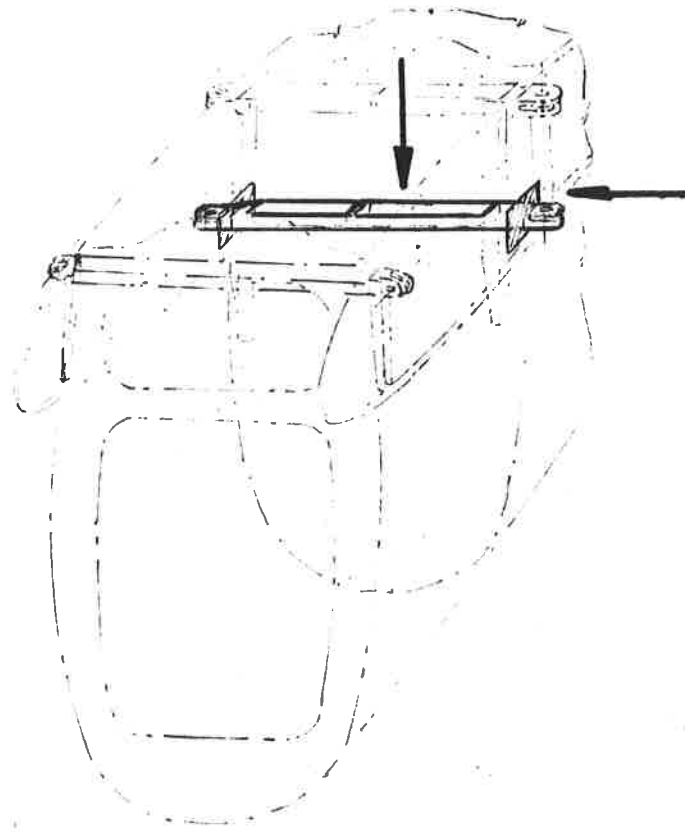
1

- Check for water leaks into the bottom flangeplate of the centre-section spar /see Fig.1/. Remove all moisture, if any, check for signs of corrosion and remove any corrosion from attacked surfaces using an emery cloth. Apply a protective coating afterwards. A gap between the rib and attachment fitting on the side of fuselage to be covered by an aviation fabric attached by an adhesive.

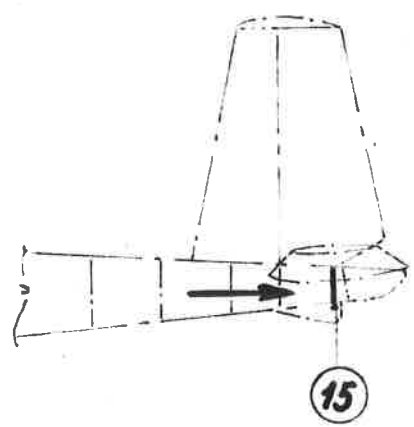
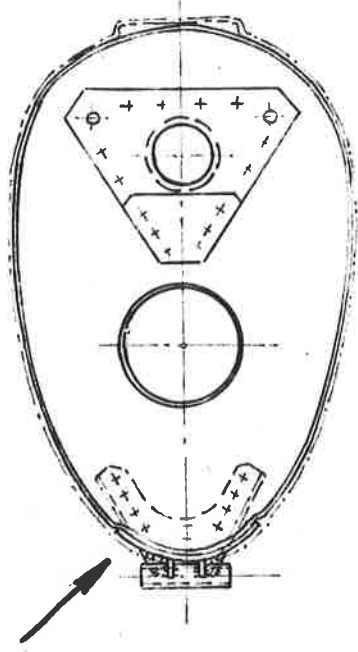
2

- Check the fuselage frame No. 15 for possible cracking within the tail skid mounting structure /see Fig. 2/. The aircraft is air worthy even in case of two cracks of 10 mm length max. in the bottom frame structure where the tail skid is attached. Ends of such cracks must be drilled off using a drill of 2.1mm dia. Should the length of these cracks exceed the above limit, the frame is to be replaced. Replacement of the fuselage frame is required also in case there are more than two cracks found in the structure.

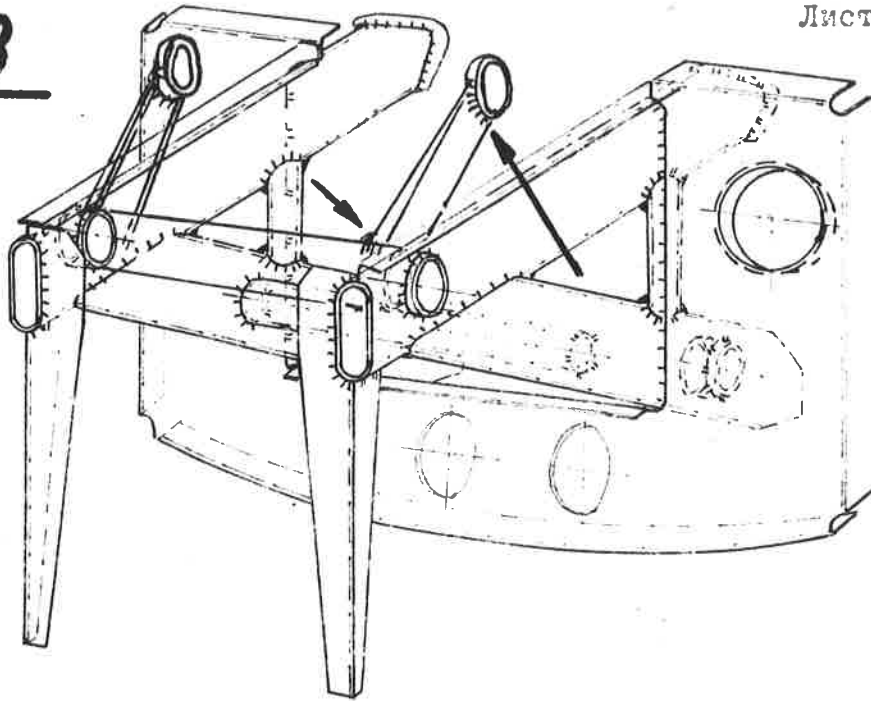
3

- Check for damage and security of the tail skid rubber silencer. Replace partially cracked silencer if necessary.
- Check the undercarriage silencer mounts and the undercarriage mounting structure /support/ /refer to Fig. 3/ for cracks. Check all welded areas for cracks and replace any damaged parts.

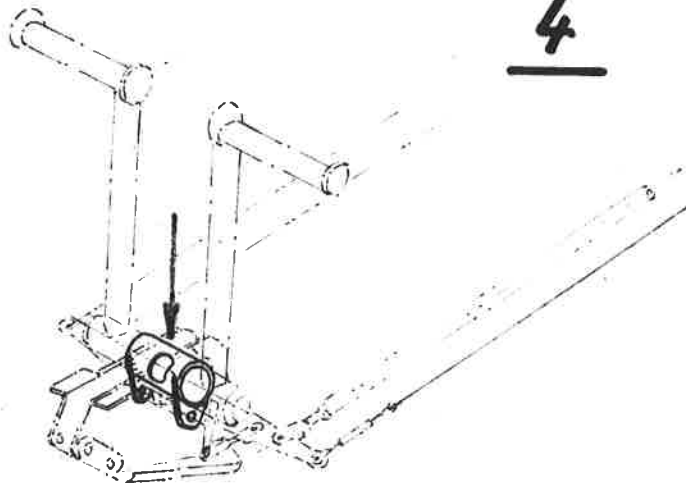
4

- Check the front pedal controls rocker lever for cracks /Fig.4/. Replace in case this check has revealed any crack. Check for clearance at the end of the foot pedal and use two extreme limit settings of the pedal travel only if the clearance exceeds 2 mm.
- Check for proper clearance of the rudder pedal controls. If the end clearance of pedal when forced sideways exceeds 1 mm, replace its support structure.
- Check the elevator drive for cracks /see Fig.5/. Replace the drive in case any crack is found.

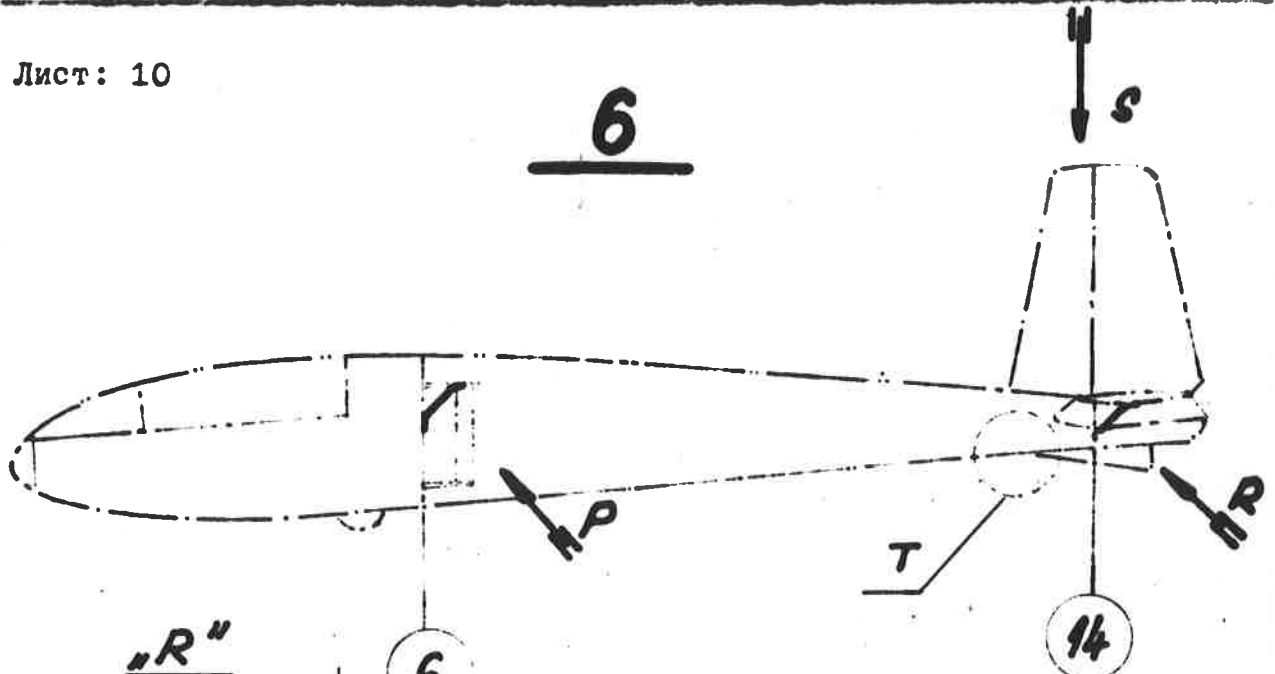
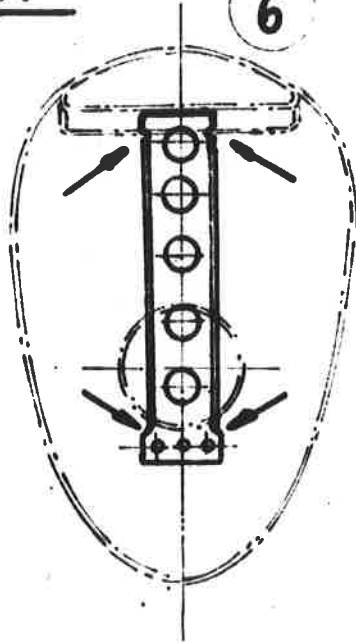
- Check the stiffeners according to Fig. 6 for cracks within the area designated by an arrow. Cracked stiffeners shall be replaced.
- Check for safety of the front tail skid attachment. Should the mount be damaged, replace it for a new one SK-L 13.165 and strengthen its attachment structure on either side of fuselage using a sheet panel of .8 mm thickness and about 50x100 mm size, made from a material designated D 16 T /see Fig. 7, detail view "T"/.

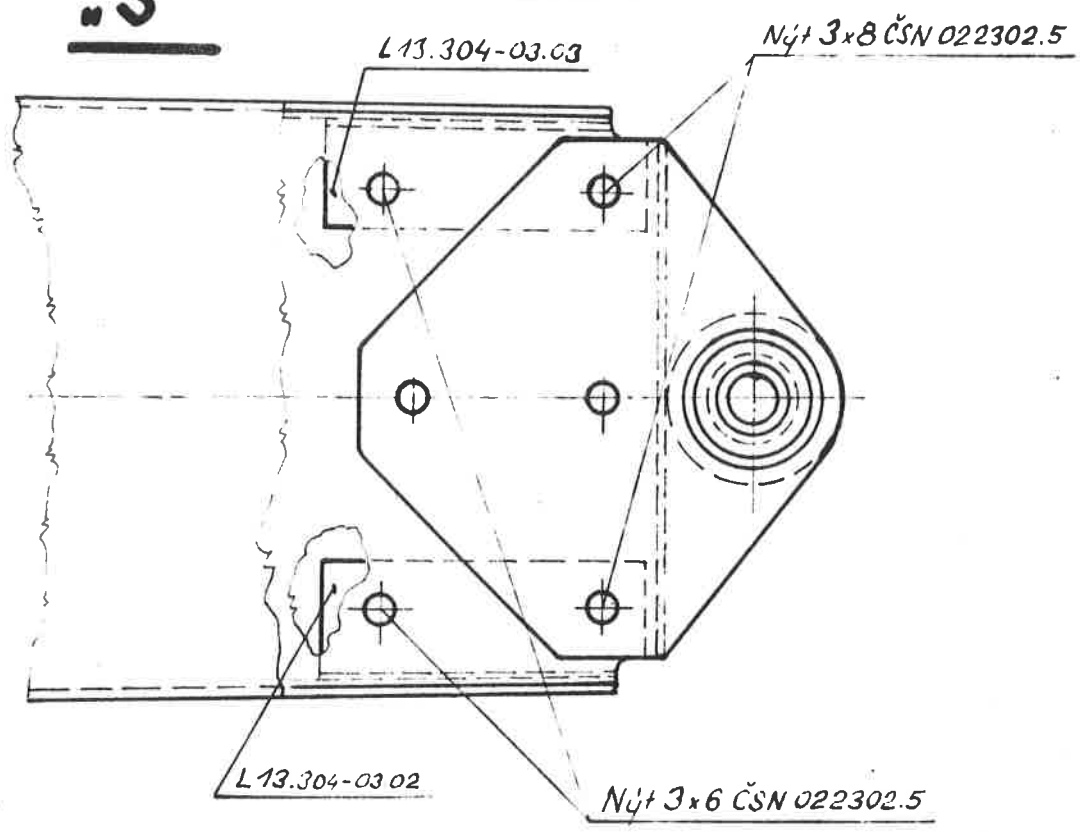
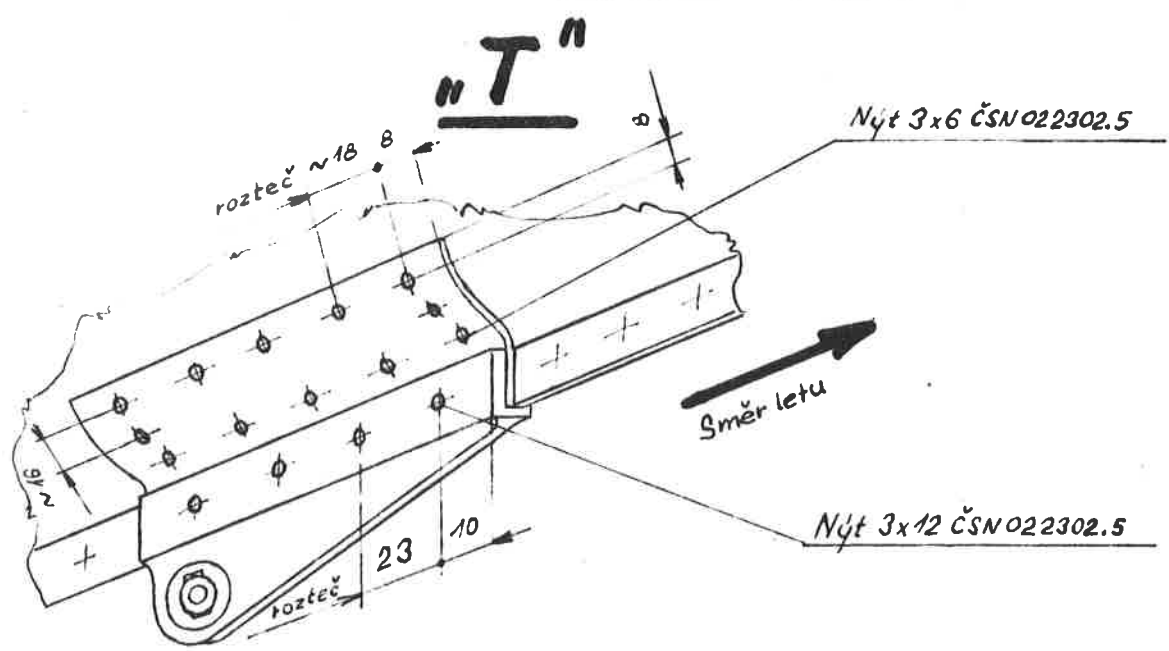
7

- Check for proper attachment of the top rudder mount on the topmost fin rib and its surrounding area for cracks. Reinforce the area by angle pieces if any crack are found. Refer to angle piece No. L13.304-03.02 /see Fig. 7, view "S"/
-03.03

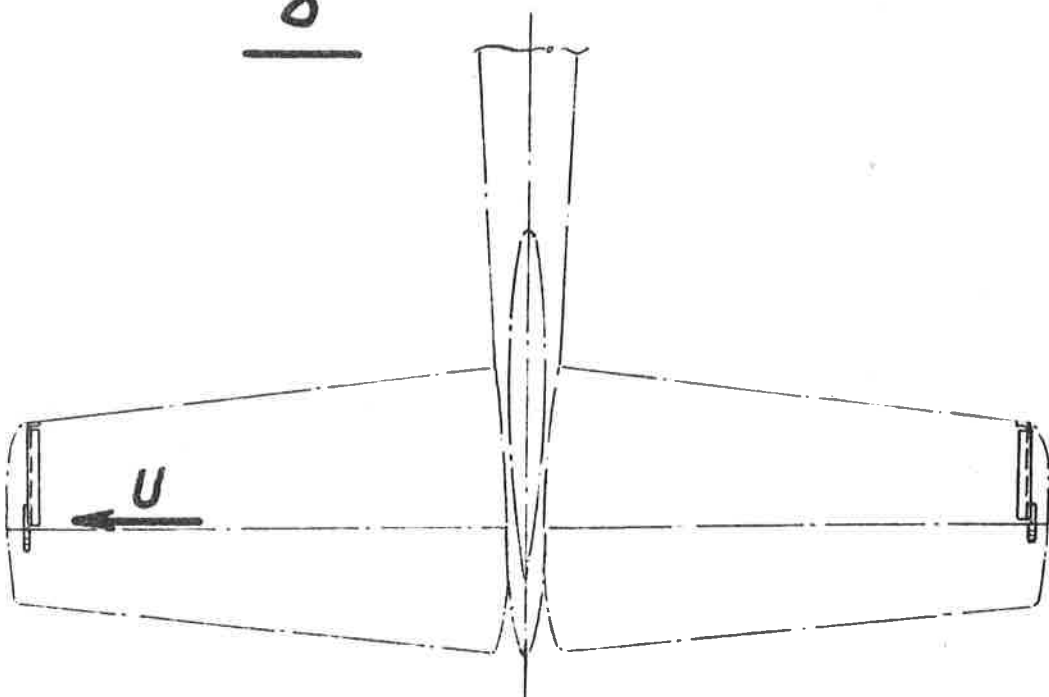
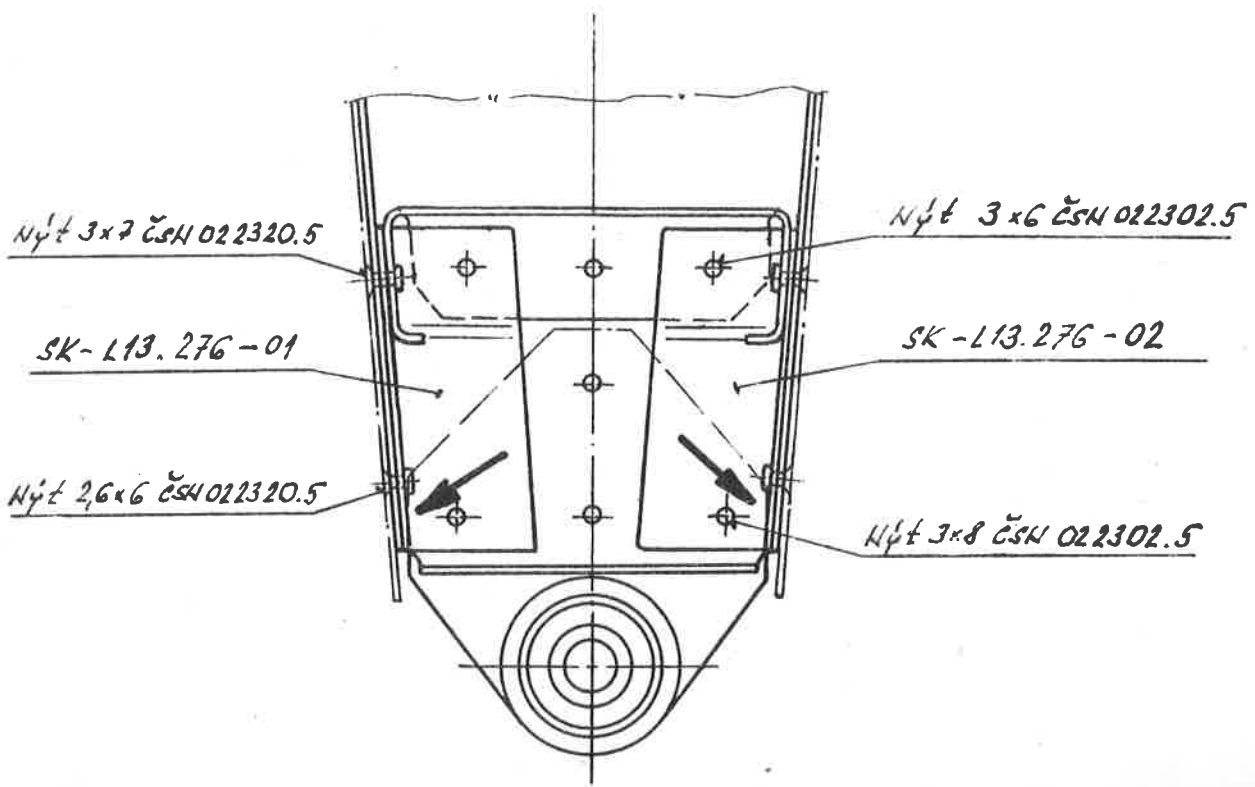
8

- Check of the elevator edge rib radii for cracks /see Fig. 8/. In case any cracks are found, drill off their ends using a drill dia. 2.1mm and stiffen the ribs by angle pieces SK-L 13.276-02 /see Fig. 8, view "U"/and SK-L 13.276-01.

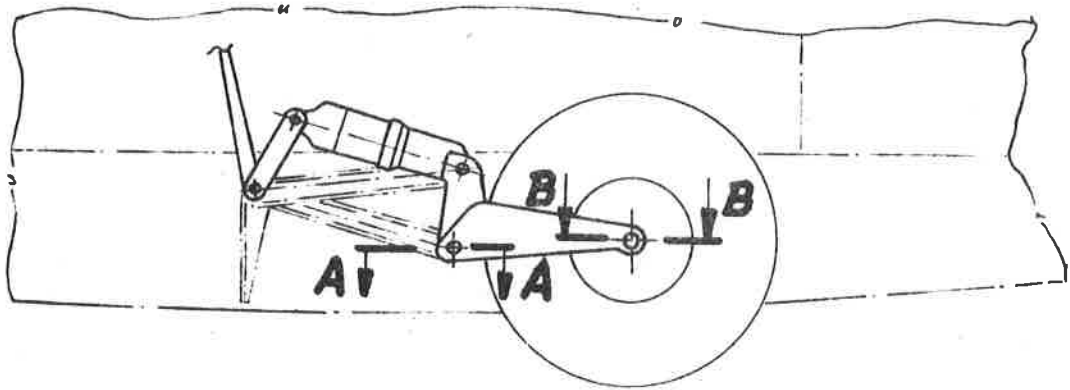
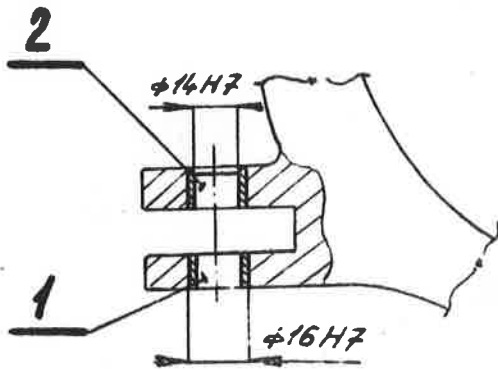
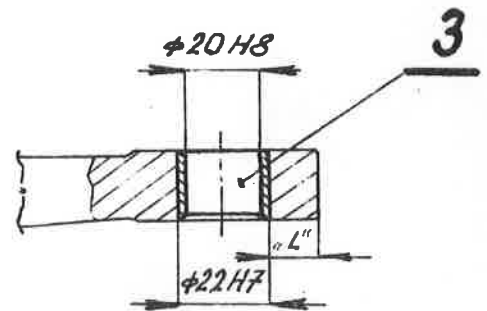
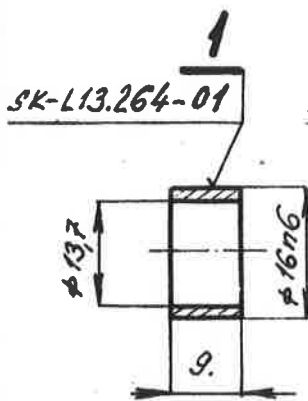
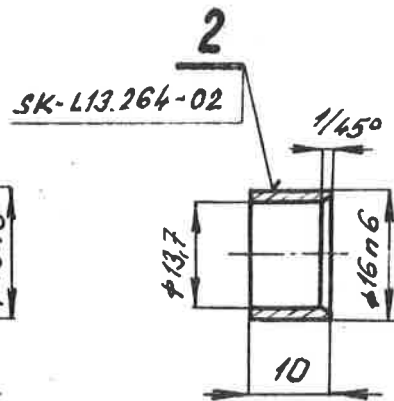
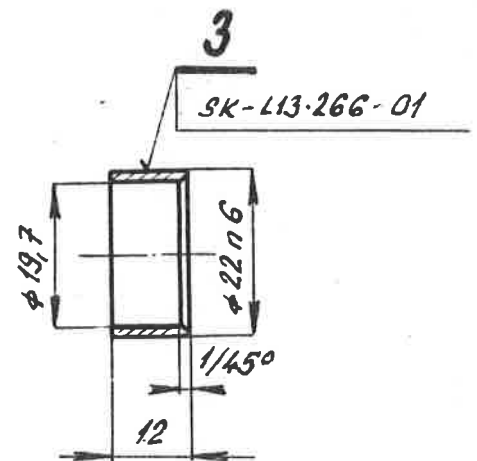
9.

- Check for proper clearances of the undercarriage fork /Fig. 9/. The holes and bolts are of the following size:

Refer to section A-A - the hole dia. in fork: 14H7
dia. of bolt: 14f8

Refer to section B-B - the hole dia. in fork: 20H8
dia. of bolt: 20f8

Should the sizes be different and the holes damaged, the following instructions are to be followed in case of a repair:

I. Section A-A

- 1) Reream the holes in fork and support to 14.1H7 dia. or 14.2H7. Install new bolts into the reamed holes. Refer to T.P.G.O./013-058 (dia. 14.1f8) or to T.P.G.O./013-059 (dia. 14.2f8).
- 2) In case of larger clearances ream the holes in fork to 16H7 dia. and press in the bronze bushing (refer to mat. 423016.31). After the bushing has been pressed in, ream the hole to 14H7 dia. The bushings can be manufactured in accordance with Fig. 9 or ordered at the manufacturer according to Dwg.No. specified next to the item. Damaged bolts to be replaced for new ones of the same type.

II. Section B-B

Ream the holes in fork to 22H7 dia., keeping the edge distance, "L", .7 mm min. Press in the bronze bushings, item 3 and replace the bolt for a new one if damaged.
