Aircraft Industries, a.s.

MANDATORY BULLETIN

MB No. : L23 / 050a REVISION No. 2

Concerning: All L23 Super-Blanik sailplane .

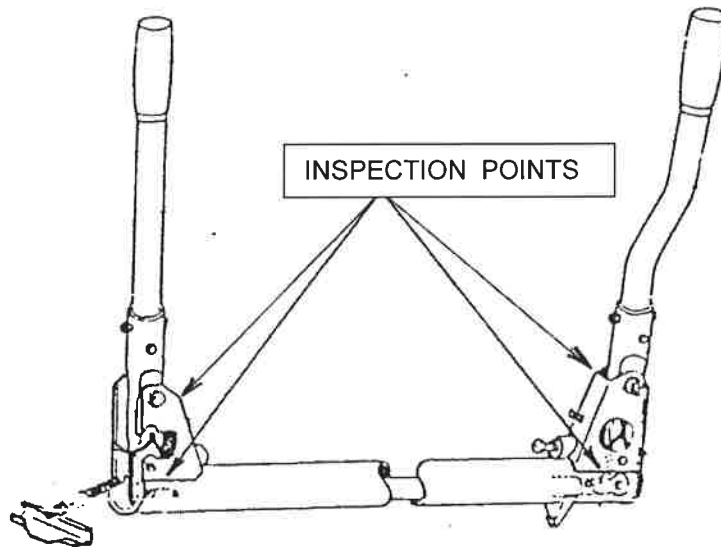
Pic.No. 1

1. Dismantle the covers of both front and rear lever .
2. Inspect visually by means of 6x zoom magnifier the bedding of front and rear control lever on the control bridge Dwg. No. A740 370N (or old design A741 210N – if installed) at the places around welds and bends (according to pic.1 on both sides of the bridge) for presence of cracks .
Lighten up inspected the places properly. For visually inspection deflect gradually the control lever to the right side endstop (minimum aileron deflection) and still press on the control lever handle to the right with moderate pressure 40 ± 10 N up to the endstop - inspect the relevant part of the bridge, at which springing it causes sharpening of eventual cracks. By the same method carry out inspection at left deflection of control lever. Crack incidence is not allowed . Carry out checks at designated places of the control bridge at control levers in front and rear cockpit.

5. In a case that some cracks in a bedding have been found, it is necessary to carry out replacement of defected bedding Dwg.No. A740 371N in control bridge assembly Dwg. No. A740 370 N before continuing sailplane operation.
Carry out replacement according to the Maintenance Manual L23 SUPER-BLANIK . Before replacement remove 2 pcs of bearings from the original Bearing A740371N according to the procedure in Apendix No.1. of the bulletin and install them into the new bedding, provided they are in a good condition.
