MANDATORY BULLETIN

MB No.: L23/051a

Concerns: All L23 Super-Blanik sailplanes.

Subject: Checks for cracks at ribs and stringers in areas of wing skin joints at ribs No. 7 and 13 of the wing.

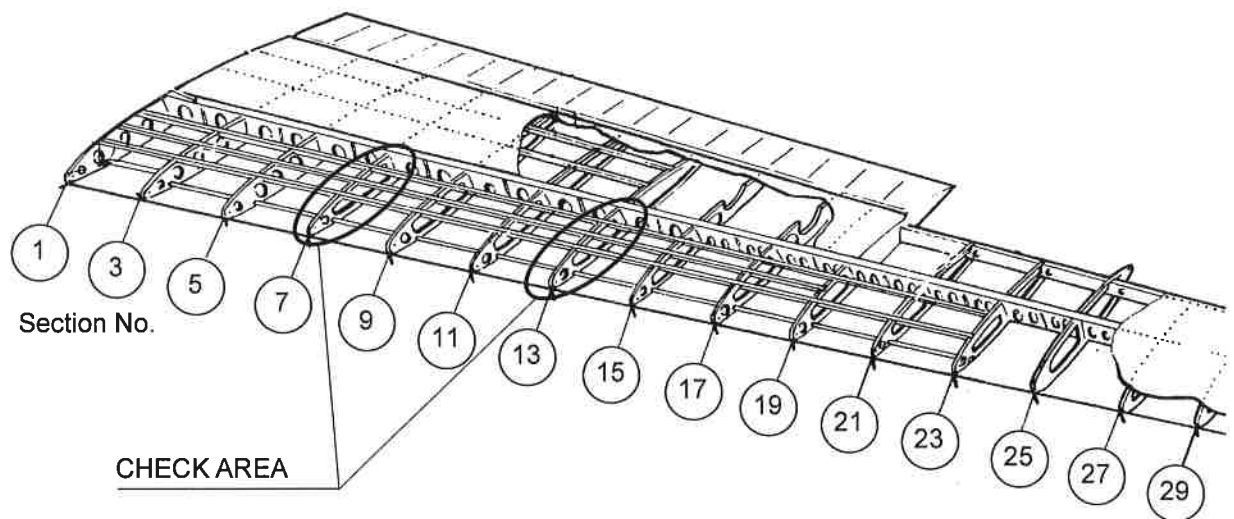
C. ILLUSTRATED PART

Check the ribs and stringers (at both sides of a rib) edges for cracks in the leading part of the wing, in sections No. 7 and 13. Pay special attention also to stringers throughout areas and rivet joints quality during the ribs and stringers edges check. Some cracks of stringers may be appeared during sailplane operation with loose wing skins rivet joints. Lighten critical places inside the wing properly and check visually by means of suitable mirror or by an endoscope. The sections No. 7 and 13 are accessible through lids on the wing skin. The section No. 13 can be best checked through the mounting hole after the down air brake is dismantled.

In case of detection of a stringer or rib failure, perform repair according to IB L13/107b. Devolve on manufacturer information about damage extent and the sailplane basic data (Registration Number, Serial Number, total number of flight hours and take offs).
