MANDATORY BULLETIN

MB No.: L23/053a

Concerns: All L23 Super-Blanik sailplanes.

Subject: Inspection of welded bracket (Drwg. No. A730 420N) located on the fin.

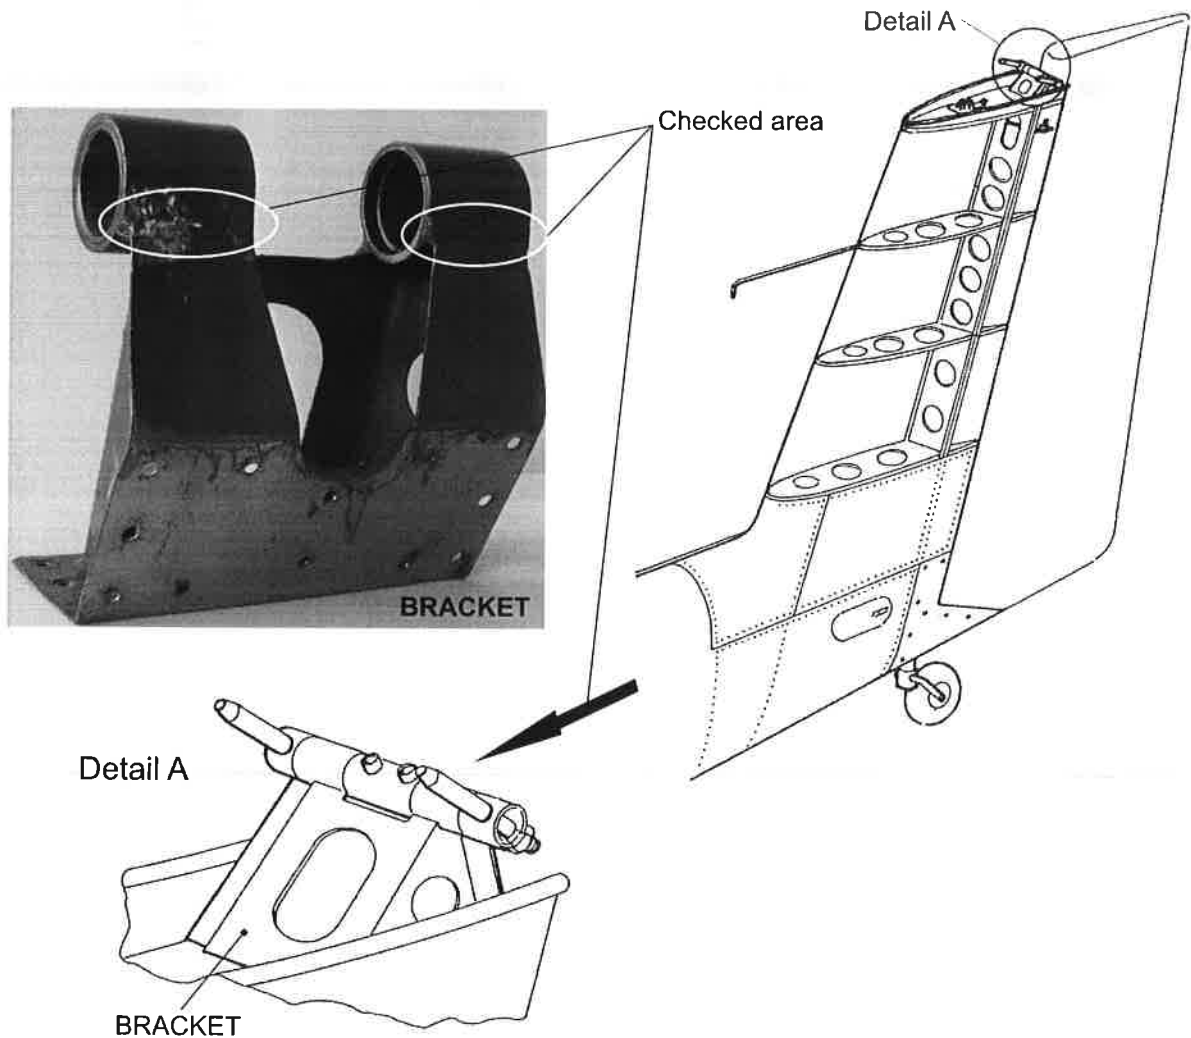
C. ILLUSTRATED PART

Reason: Appearance of cracks on the bracket.

- Checked area: weld in sleeves areas with special focus to the critical areas marked on the figure in part C of this bulletin.
- Perform the check by means of magnifier (6 times magnifying).
- Admissibility criteria: No cracks in checked area of the bracket are admissible.
- If no cracks are present on the checked bracket, perform record in the Airframe Logbook according to the part I.
- If cracks has been detected on the checked bracket, the saiplane further operation is prohibited. Perform replacement of the damaged bracket according to the IB L23/054b.

In case of cracks detection, send the bracket to the sailplane producer together with basic data of the saiplane (registration mark, S/N, total flight hours and number of starts since the sailplane has been put into the operation).
