MANDATORY BULLETIN

MB No: L23/060a Revision 2

Concerns: All L 23 SUPER-BLANÍK.

Subject: Inspection check of controls cable attachment screws and rudder hinge bolt

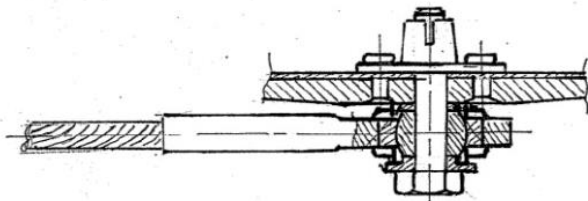
Fig. A

Design valid up to 79th series
Rudder control cable "screw"

A.1 DISMOUNT (up to 79th series including – Fig.A)

1. Dismount the rudder according to the maintenance manual. (page 402-404, 27-20-00)
2. Place the rudder on the supports to allow good access to the cable attachment screws P/N A730515N and P/N A740259N, and rudder hinge bolt P/N A730514N - pos.21 (2x) pos. 22 on figure 1, page 3, 27-20-00 of the maintenance manual).
3. Clean and degrease the screws and hinge bolt.
4. Perform the penetrant testing on the entire accessible shoulder, thread undercut and thread of the screws and hinge bolt according to specification ASTM E1417-16, TYPE II, METHOD C, FORM e. The penetrant test must be performed by an approved organization.
5. Acceptance criteria: No cracks in checked area.

6. In case of passing the test – provide a record in the Airframe Logbook according to the part G of this bulletin. The operation of sailplane is permitted.
7. If cracks have been detected on the checked area, the operation of sailplane is prohibited. Send to the sailplane TC holder:
 - Registration mark
 - Serial Number
 - Total flight hours
 - Number of starts by winch and aerotowSailplane TC holder will send you the service bulletin No. L23/061b in order to perform the replacement of damaged screws.
8. Install the rudder according to the maintenance manual (page 402-404, 27-20-00)

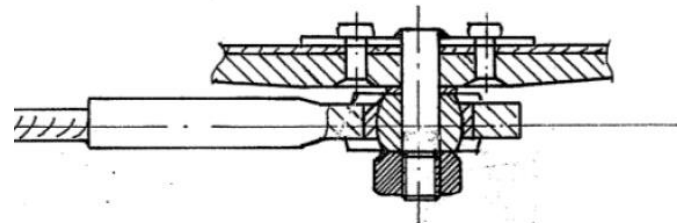
Fig. B

Design valid since 80th series
Rudder control cable "stud bolt"

A.2 DISMOUNT (from 80th series – Fig. B)

1. Dismount the rudder according to the maintenance manual. (page 402-404, 27-20-00)
2. Place the rudder on the supports to allow good access to the cable attachment stud bolts P/N A730545N and P/N A730540N, and rudder hinge bolt P/N A730514N - pos.21 (2x) pos. 22 on figure 1, page 3, 27-20-00 of the maintenance manual).

3. Clean and degrease the stud bolts and hinge bolt. (Do not drill-out the stud bolts out of the rudder).
4. Perform the penetrant testing on the entire accessible shoulder, thread undercut and thread of the stud bolts and hinge bolt according to specification ASTM E1417-16, TYPE II, METHOD C, FORM e. The penetrant test must be performed by an approved organization.

5. Acceptance criteria: No cracks in checked area.
6. In case of passing the test – provide a record in the Airframe Logbook according to the part G of this bulletin. The operation of sailplane is permitted.

7. If cracks have been detected on the checked area, the operation of sailplane is prohibited. Send to the sailplane TC holder:
 - Registration mark
 - Serial Number

- Total flight hours
 - Number of starts by winch and aerotowSailplane TC holder will send you the service bulletin No. L23/061b in order to perform the replacement of damaged Stud bolts

8. Install the rudder according to the maintenance manual (page 402-404, 27-20-00)

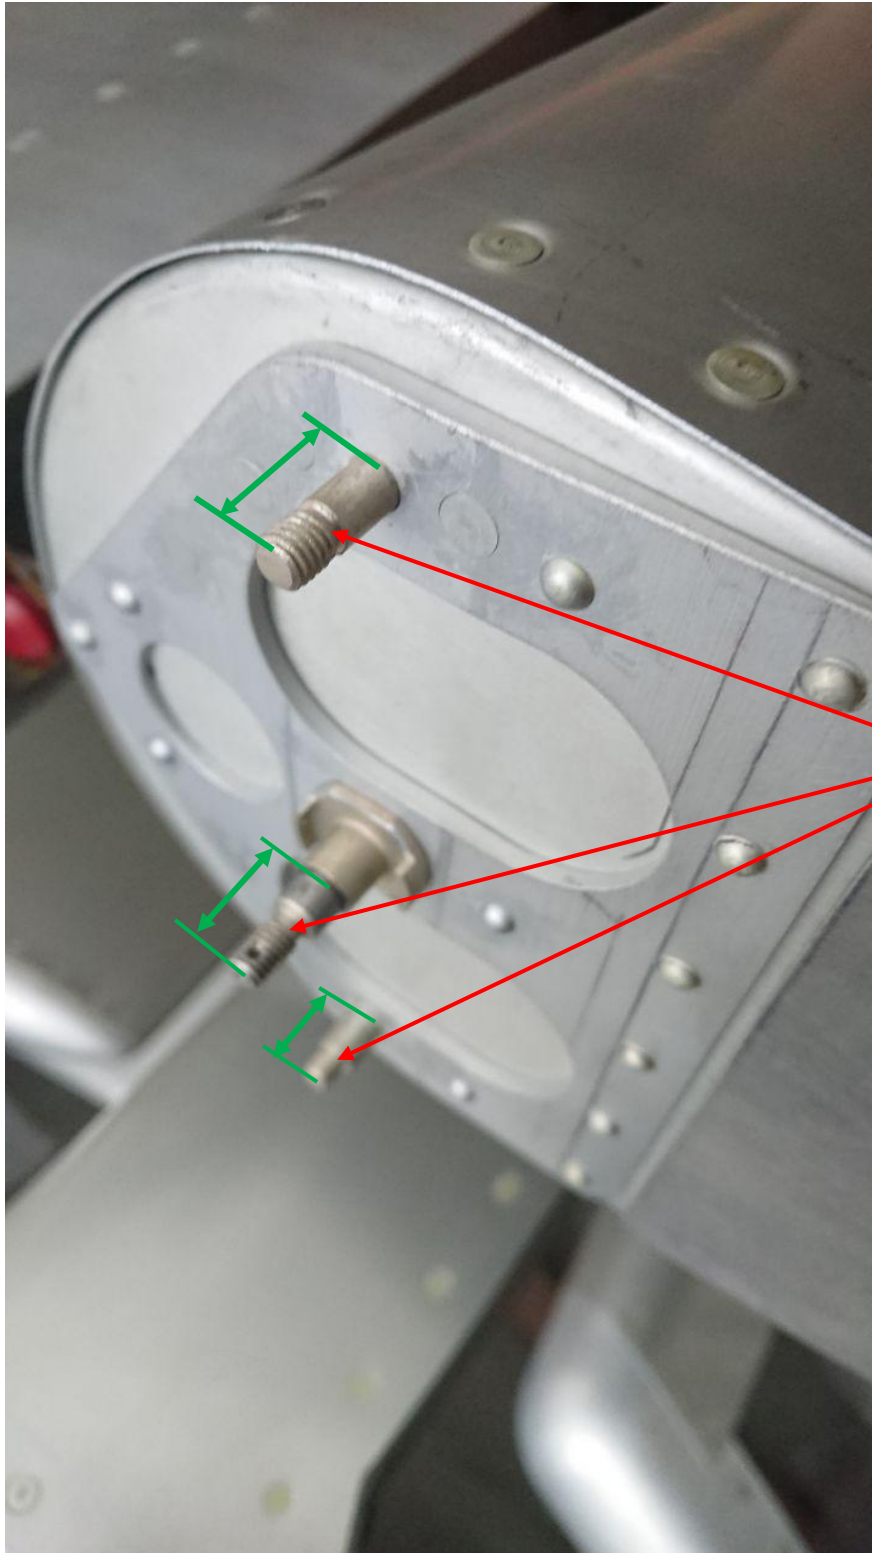
**Screws and bolt for inspection**

This seem to be the stud bolts and the hinge bolt from series 80 on.
