QUIV Trust of Czechoslovak Aeronautical Works Prague Czechoslovakia

MANDATORY BULLETIN No. 1 13/062

Effectivity: All gliders L 13 and L 13 A Blaník after they have flown

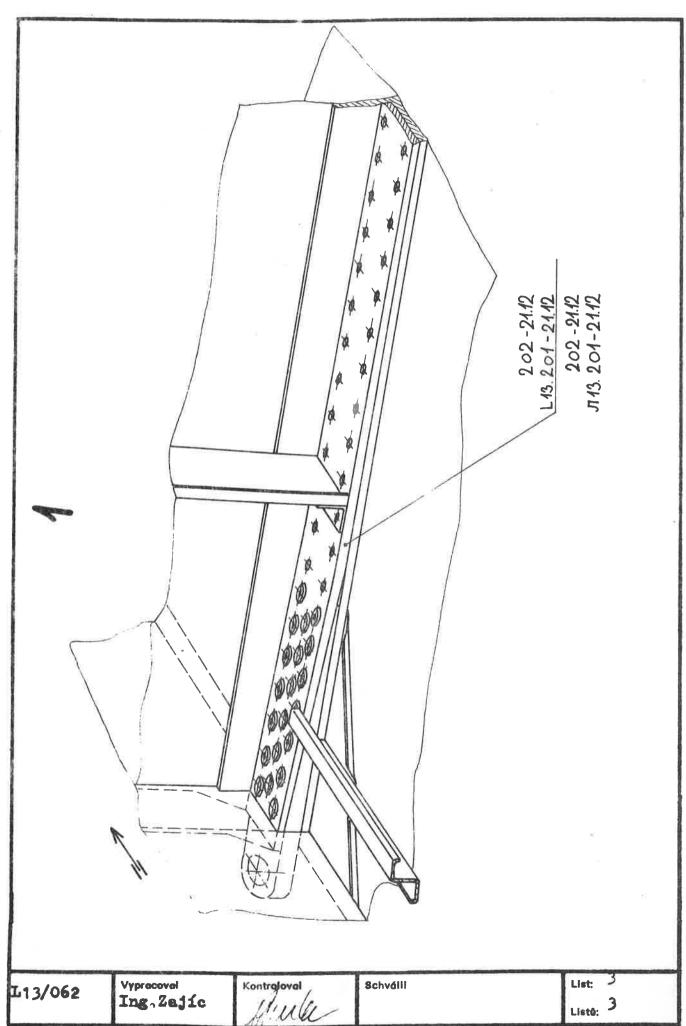
a crack fissure on the flange strap situated on the wing 's main spar lower flange in the area of the hinge.

- 1. Dismantle the wing of the fuselage.
- 2. Place the wing on suitable stands.
- 3. During the hole in the rib No. 1 put a lamp into the cavity of the wing behind the main spar.
- 4. Check the flange strap on the lower flange Dwg. No L13.201-21.12 /L13.202-21.12 for the right side/ and accessible parts of the spar's lower flange in the area between rips No. 1 3 for crack fissures /fig. No. 1/. Especial locate the places around the rivets, from where the crack fissure's direction of propagation to the flange strap is probable.
- 5. As far as there have not been found any crack fissures, attach the wing back on the fuse lage.

In case that you have found crack fissures, stop immidiately the operating with the glider, announce this fact to the manufacturer and wait at his standpoint.
