MANDATORY BULLETIN

MB No: L 13/078a

Concerning: Technical Manual of the L13 Sailplane, 4th Edition - February 1977

Reason: Determination of allowable plays in deflections of elevator trim tab and method of their measuring and inspection in operation.

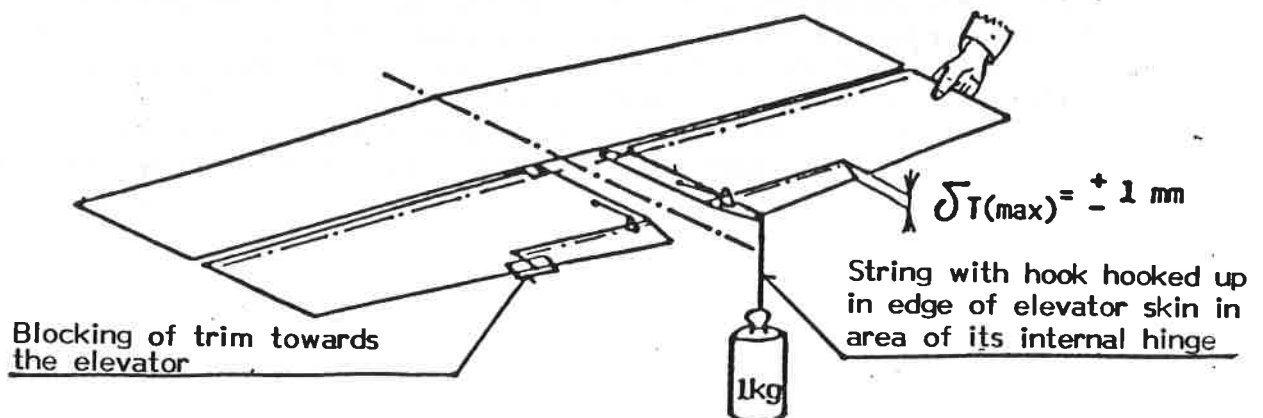
Scheme No. 1: Measuring of clearances in rotation of elevator trim TAB

Admissible clearance in control of elevator trim tab -
- measured on the tab trailing edge in vertical plane at zero position of the elevator and the tab +1 mm

Measure the clearance in control of the elevator trim tabs at zero position of the elevator and the tabs by the following procedure:

- block in suitable way one of the tabs on the trailing edge towards the elevator (e.g. two metal sheet strips connected by a bolt)
- load the other tab with a moment which will simulate a weight of 1 kg and which is hung-up through the string on the tab trailing edge in the area of control levers (see Scheme No. 1)
- a clearance is understood as a vertical distance between the trailing edge of the tab and the elevator (δ_T [mm])
- a clearance which is in upward direction will be evaluated only subjectively by comparison with a clearance measured in downward direction
- use the same procedure also for the other tab

If the measured clearances δ_T exceed the admissible value ± 1 mm they must be fully eliminated by tightening the control strings (possibly cables) through tightening sleeves of bowdens on fuselage frame No. 14 (for gliders up to 17th series even with use of string tighteners at rear control lever of trim tabs in pilot's cockpit). Adjust the bowden tighteners in even way so that the difference in tab deflections does not occur. If the bowden tighteners travel is not sufficient for total clearance elimination it is necessary to

screw in the tighteners to the stop (so that the largest possible travel remains for following adjustment of clearances), to change the strings or cables in the bowdens, to attach them to surfaces and readjust them.

To ensure sufficient irreversibility (self-locking ability) of the trim tab control system it is necessary to tighten each of their control levers in the cockpit with tightening moment of 2 Nm.
