## MANDATORY BULLETIN

MB No: L 13/079a

Concerning: Manual for Operation and Maintenance of the L13 Blaník Sailplane without overhauls, Part 1, Edition-August 1, 1985

Reason: Determination of allowable plays in deflections of elevator trim tab and method of their measuring and inspection in operation.

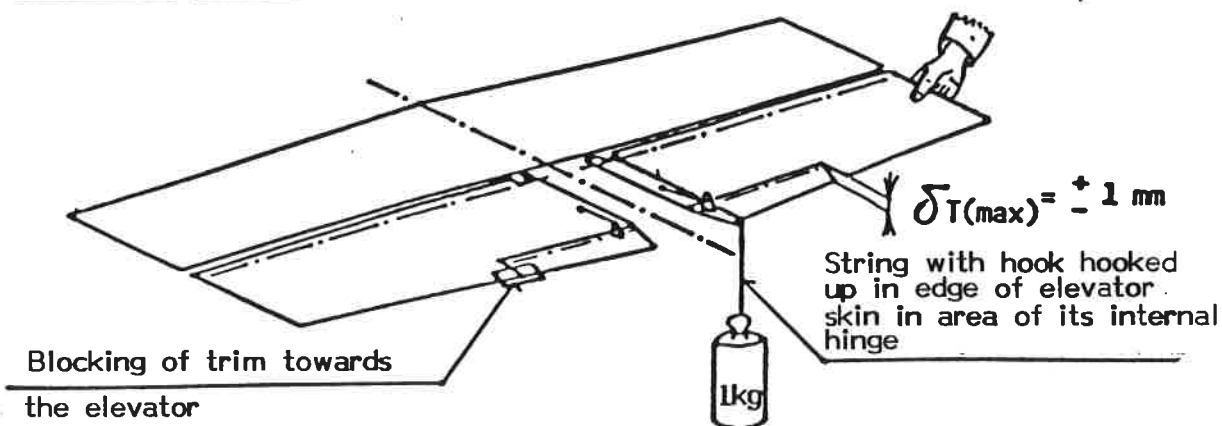
Scheme No.1: Measuring of clearances in rotation of elevator trim TAB

- Rudder control - measured on the foot control pedals ..... 3 mm
  - Elevator trim tab control - measured on the tab trailing edge in vertical plane with neutral position of the elevator as well the tab .....  $\pm 1$  mm

- Measure the clearances in the tab control by the following procedure:
- block one of the tabs in suitable way on the trailing edge to the elevator (e.g. using two metal sheet strips connected with bolt and nut)

- load the other tab with a moment induced by a weight of 1 kg hung-up through a string on the tab trailing edge in the area of control levers (see Scheme No. 1)

- measure the surface clearance ( $\delta_T$  mm) which is understood as a vertical distance between the trailing edge of the tab and the elevator
  - a clearance which is in upward direction will be evaluated only subjectively by comparison with a clearance measured in downward direction

- use the same procedure also for the other tab

If the measured clearances  $\delta_T$  exceed the admissible value  $\pm 1$  mm they must be fully eliminated by tightening the control strings (possibly cables) through tightening sleeves of bowdens on fuselage frame No.14 (for gliders up to 17<sup>th</sup> series even with use of string tighteners at rear control lever of trim tabs in pilot's cockpit). Adjust the bowden tighteners in even way so that the difference in tab deflections does not occur. If the bowden tighteners travel is not sufficient for total clearance elimination it is necessary to screw in the tighteners to the stop (so that the largest possible travel remains for following adjustment of clearances), to change the strings or cables in the bowdens, to attach them to surfaces and readjust them.

To ensure sufficient irreversibility (self-locking ability) of the trim tab control system it is necessary to tighten each of their control levers in the cockpit with tightening moment of 2 Nm.
