# MANDATORY BULLETIN

No. L13/085a

Concerning: L13, L13A sailplanes

Reason: On the L 13 BLANIK sailplane S/N 027226, the tail-fuselage attachment fitting P/N A 102 021 N made of 424253.11 material has been damaged in service.  
The material of this component must be tested as instructed in this Bulletin.

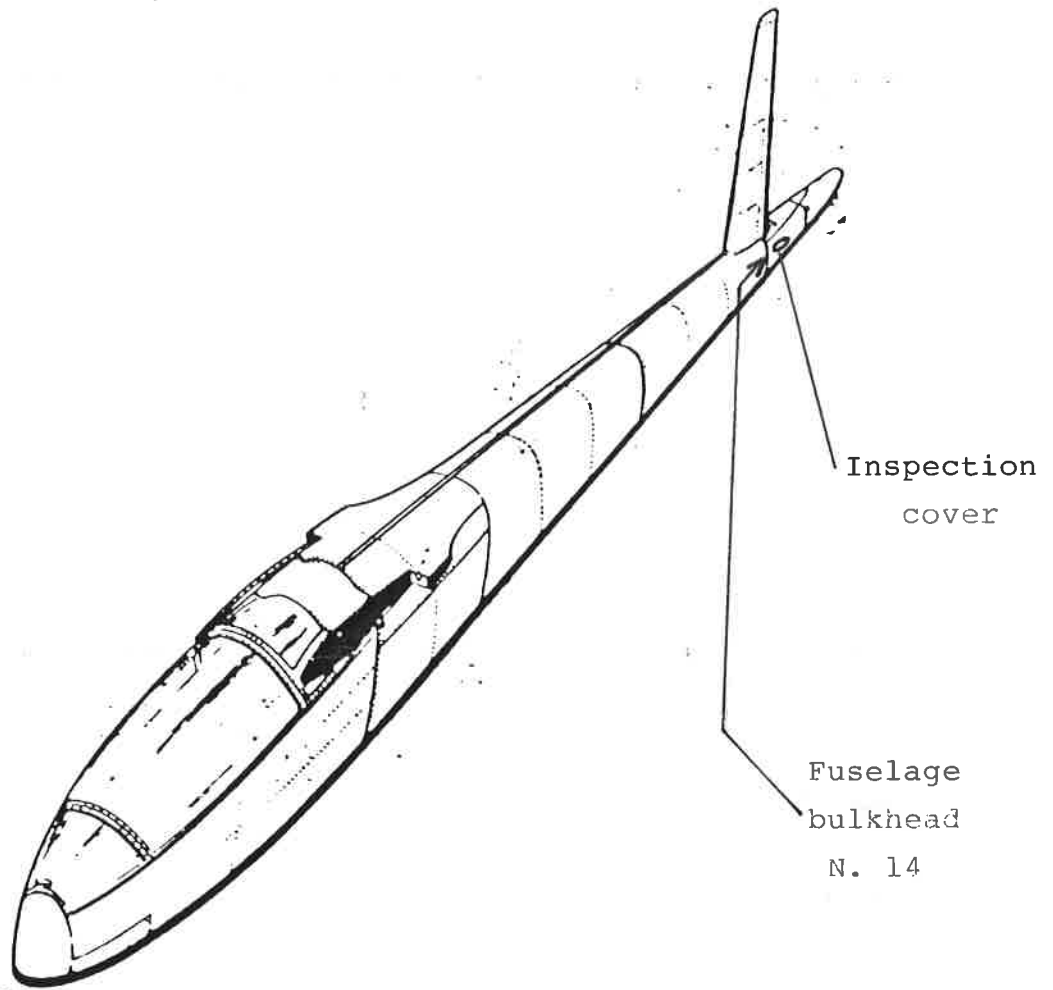
Fig. 1

1. Remove the oval cover located on the LH side of the fuselage, under the horizontal stabilizer.
2. Test the material of the attachment fitting P/N A 102 021 N as follows:
  - a) Conductivity measurement by means of eddy currents:
    - Recommended measurement frequency: 60 kHz
    - Probe diameter: not exceeding 15 mm
    - Measuring contact point: lower milled surface of the component, between the rivets (see Figs 1 and 2).

Measuring contact point

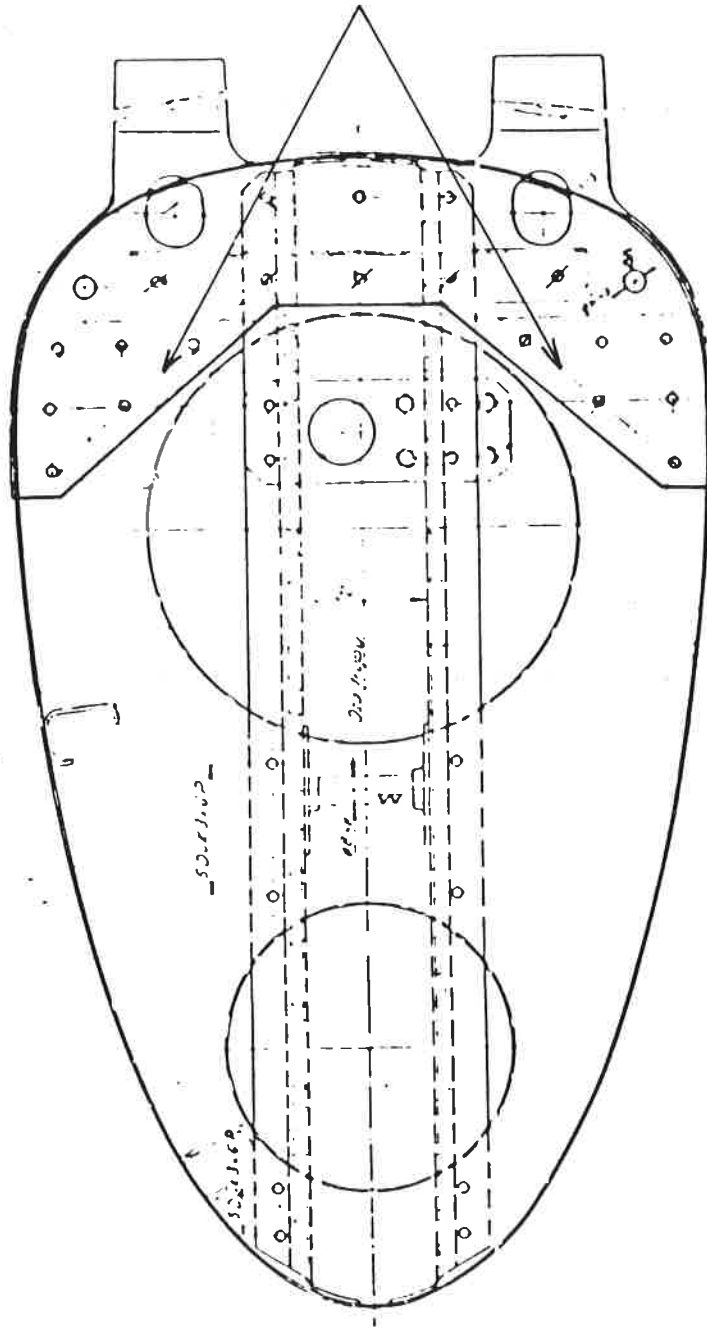
Fig. 2

Fuselage bulkhead N. 14 with attachment fitting P/N  
A 102 021 N
