MANDATORY BULLETIN

MB No.: L13/095a

Concerning: Gliders L13AC S/N 988601, 988603, 988604, 008605, 008606
Gliders L13A S/N 817401

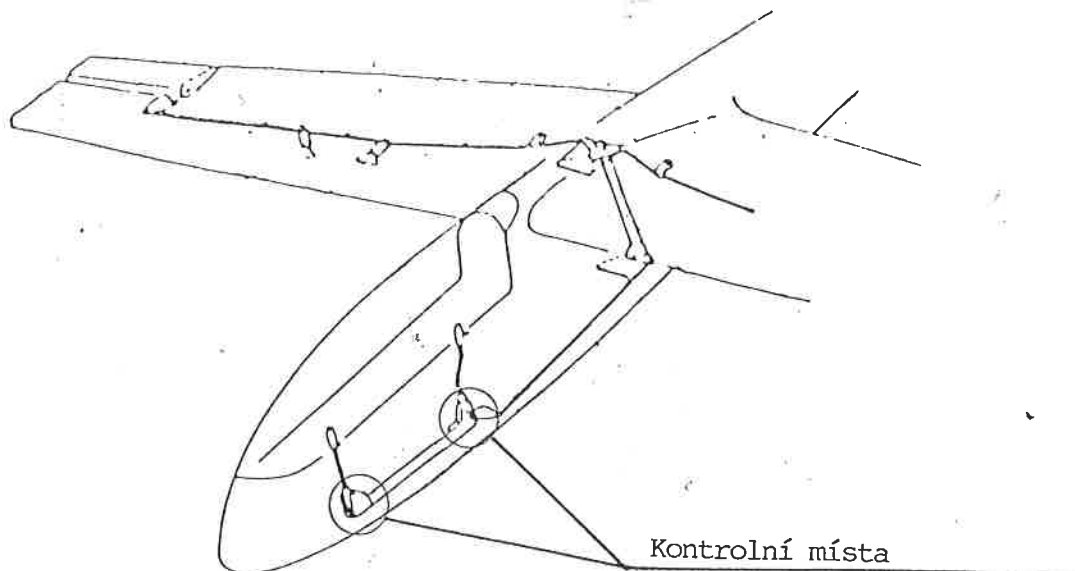
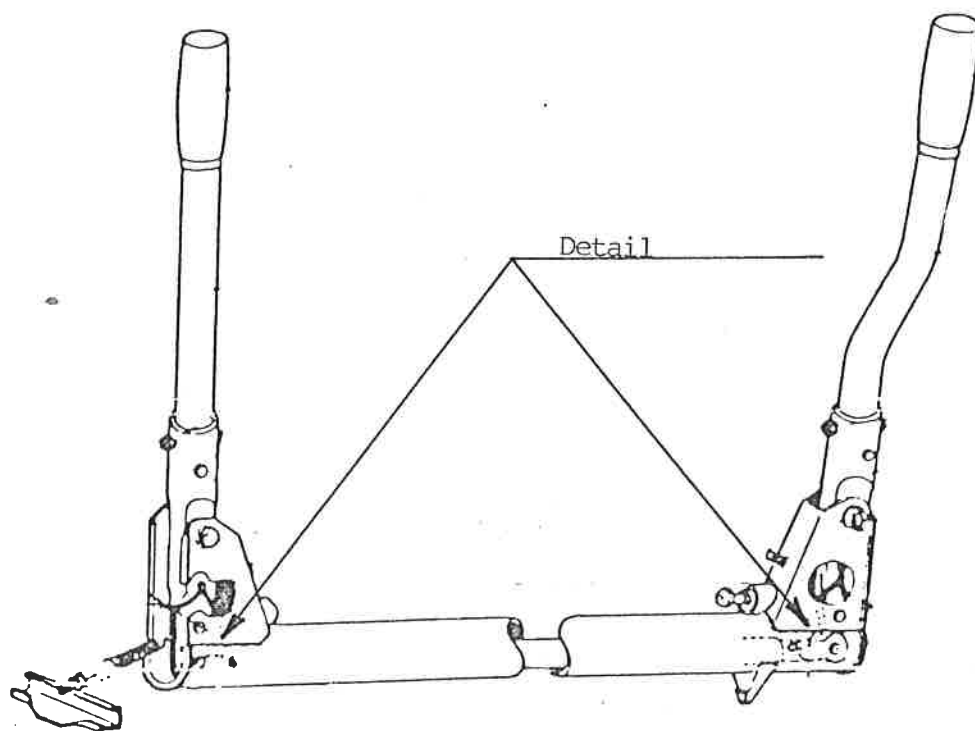
OBR. 1 MŮSTEK ŘÍZENÍ
 FIG. 1 FLIGHT CONTROL BRIDGE
 ФИГ. 1 МОСТИК УПРАВЛЕНИЯ

Reason: Cracks in bedding of control levers on bridge of controls Dwg. No. A741 210N on glider L13AC S/N 988604 have occurred in operation after 130 flight hours of full aerobatics.

1. Dismantle the covers of both front and rear lever.
2. Inspect visually by means of a magnifier 6x magnifying the bedding of front and rear control lever Dwg. No. A741 215N on the bridge of controls Dwg. No. A741 210N on the places around welds for cracks (according to pic. 1 on both sides of bridge).
Inspect the area by more accurate NDI method (e.g. color crack detection) with suspicion of the cracks occurrence from visual method.
The cracks occurrence is not allowed.

5. In the case of the bedding cracks finding, it is necessary to carry out prior to further operation the change of bridge of controls Dwg. No. A741 210N according to Chap. 7.7. of L13AC Blanik Maintenance Manual. Carry out the record in the Glider logbook after implemented change.
Inform a producer immediately after found defect with simultaneous referring of data on the glider operation with a view to share of aerobatics.
