MANDATORY BULLETIN

MB No.: L13 / 105 a

Concerning: All L13, L13A BLANÍK gliders

Reason: Check of the control bridge at the place of gripping of control levers

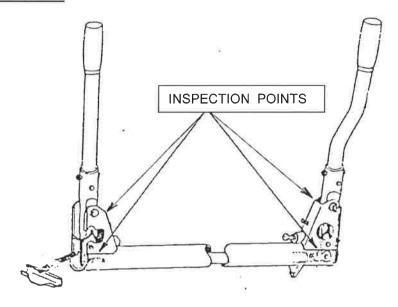
Fig. No. 1

- 1. Dismantle the covers of both front and rear lever.
- 2. Inspect visually by means of 6x magnifying magnifier the bedding of front and rear control lever on the control bridge Dwg. No. A401 001N (old Dwg. No. L13.401-Z1) or Dwg. No. A740 370N, according to the specified design of sailplane, at the places around welds and bends (according to Fig.1 on both sides of the bridge) for presence of cracks.
 Lighten up inspected places properly. For visually inspection deflect gradually the control lever to the right side endstop (minimum aileron deflection) and still press on the control lever handle to the right with moderate pressure 40 ±10 N up to the endstop inspect the relevant part of the bridge, at which springing it causes sharpening of eventual cracks. By the same method carry out inspection at left deflection of control lever. Crack incidence is not allowed. Carry out checks at designated places of the control bridge at control levers in front and rear cockpit.

- 5. In a case that some cracks in a bedding have been found, it is necessary to carry out replacement of defected control bridge for a new one according to the Dwg. No. A740 370 N design before continuing operation. For L13 glider there is also installation of original control bridge Dwg. No. A401 001N allowed, provided operator or servicing centre has original Bedding Dwg.No. A741 215N (old Dwg.No. L13.401-25.P1) as unused spare part at disposal. Carry out replacement according to the Technical and Maintenance Manual of the L13 sailplane / Edition No.4 from the year 1978 or according to the Operational and Maintenance Manual of L13 sailplane without overhauls or according to the Operational and Maintenance Manual of L13A sailplane, depending on which Manual is actual for given sailplane. Inform immediately manufacturer about found defect at the same time with handover of sailplane operation data with a view to aerial acrobatics rate.
