MANDATORY BULLETIN

L13/108a REVISION 1

All sailplanes L-13 "BLANIK" and L 13 A Blanik

Check for cracks on ribs and stringers in area of connection of skin and

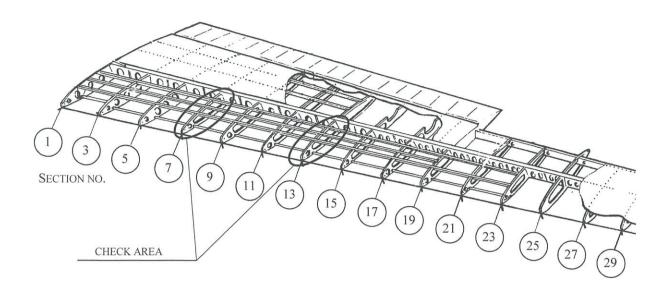
Fig. 1 – Check area according to procedure a

1. Check the ribs and stringers edges for cracks in areas of wing skin joints (ribs No. 7 and 13) from inner side of the wing. Perform the check on dismounted wings, placed in a stand, with the leading edge downward. The wing may be supported by stand surfaces in the ribs areas only and distributed load on the wing surface must be provide.

Check the ribs and stringers (a both sides of a rib) edges for cracks in the leading part of the wing, in sections No. 7 and 13. Pay special attention also to stringers edges check. Some cracks of stringers may be appeared during sailplane operation with loose wing skins rivet joints. Lighten critical places inside the wing properly and check visually by means of suitable mirror or by an endoscope. The sections No. 7 and 13 are accessible through the mounting hole after the down air brake is dismounted.

In case of detection of a stringer or rib failure, perform repair according to IB L13/107b. Devolve on manufacturer information about damage extent and the sailplane basic data (Registration Number, Serial Number, total number of flight hours and take offs).

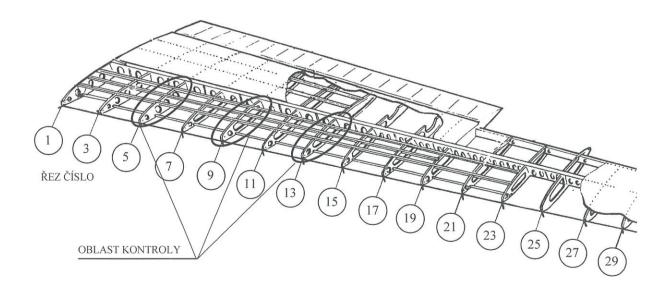
Fig. 2 – Check area according to procedure b

1. Check the ribs and stringers edges for cracks in areas of wing skin joints (ribs No. 5, 9 and 13) from inner side of the wing. Perform the check on dismounted wings, placed in a stand, with the leading edge downward. The wing may be supported by stand surfaces in the ribs areas only and distributed load on the wing surface must be provide.

Check the ribs and stringers (a both sides of a rib) edges for cracks in the leading part of the wing, in sections No. 5, 9 and 13. Pay special attention also to stringers edges check. Some cracks of stringers may be appeared during sailplane operation with loose wing skins rivet joints. Lighten critical places inside the wing properly and check visually by means of suitable mirror or by an endoscope. The sections No. 5 and 9 are accessible through the cover in the skin. The section No. 13 is accessible through the mounting hole after the down air brake is dismounted.

In case of detection of a stringer or rib failure, perform repair according to IB L13/107b. Devolve on manufacturer information about damage extent and the sailplane basic data (Registration Number, Serial Number, total number of flight hours and take offs).
