Aircraft Industries

MANDATORY BULLETIN

MB No: L13/116a

Subject: Check of the mechanical characteristics of the material the upper and lower spar cap.

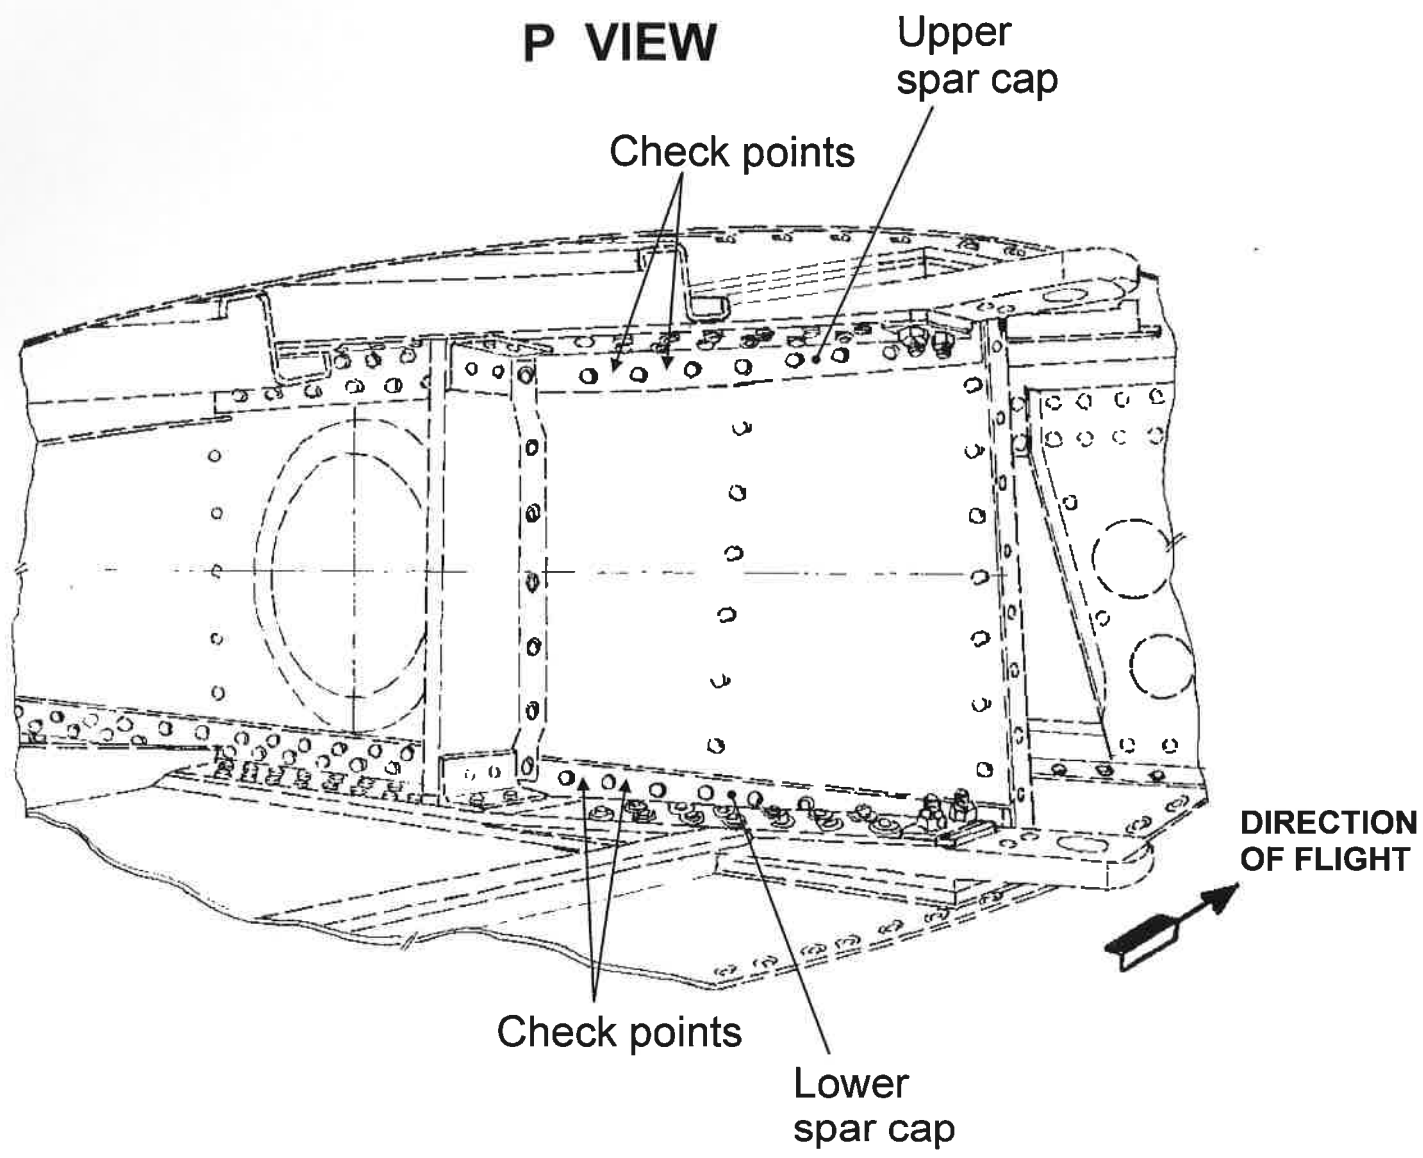
Fig. 2 - Check points on the upper and lower spar cap

3. Through a access hole, perform the check of the mechanical characteristics of the material the upper and lower spar cap as follows:
 - a. Before the check, clean the dirt and grease from the controlled space, using appropriate preparations.
For check is accessible the vertical part of the spar cap, adjacent to the spar - refer to the fig. 2.
Carry out the check in the areas described on the fig. 2.

- Measuring contact points: upper and lower spar cap (between rivets) - refer to the fig. 2.
 - c. Permissible range of measured value

% IACS (International Annealed Copper Standard)
28.5 - 34.0
 - d. Repeat the measurements several times for verify the results, in the several areas described on the fig. 2.
 - e. Any other measuring method must be approved by the sailplane manufacturer before it can be used.

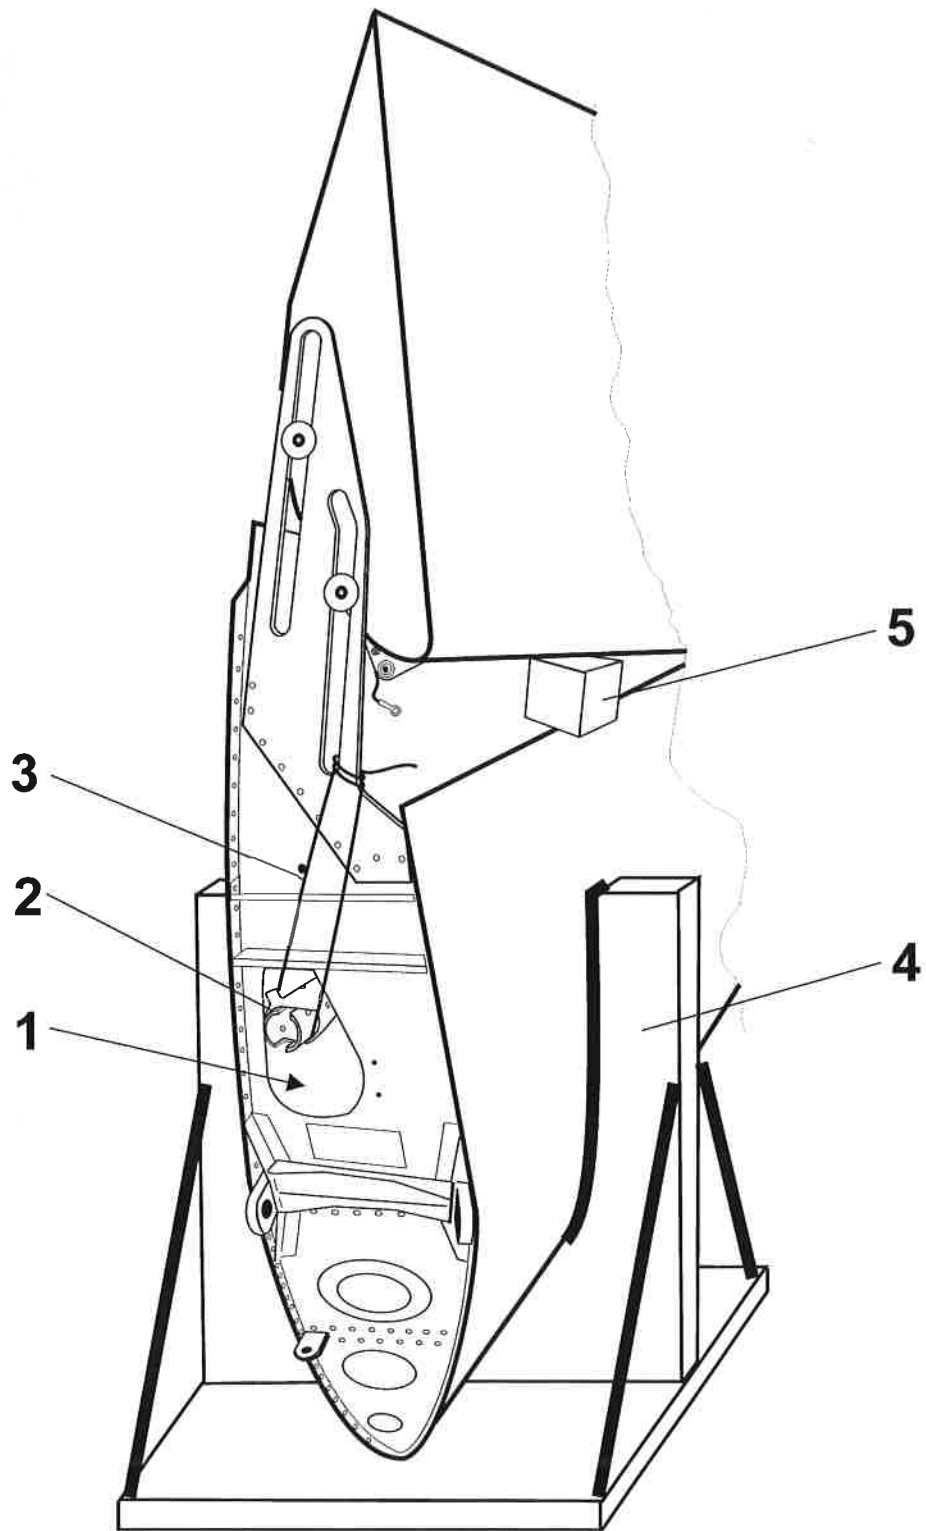
Fig. 3 - View of the prepared wing on the check

1. Remove the LH and RH wing from the sailplane.
Put the removed wings into the vertical position into the racks prepared beforehand - see fig. 3.
2. Perform the following procedures for assurance of access to check points:
