OMNIPOL PRAHA ČESKOSLOVENSKO

MANDATORY BULLETIN

No. L 13/040

Vertical stabilizer of the L 13 Blaník sailplane up to PIN 174230. Effectivity:

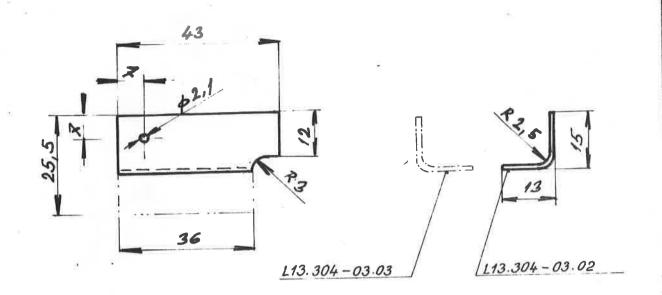
- Inspect the top rib of the fin within the rudder surface mount. Should any crack propagate as far as 5 mm, proceed with a repair as per instructions of the paragraph B below. If these cracks exceed 5 mm length, then replace the whole rib as per the paragraph C below.

- 1. Remove the two rivets on each side, connecting the skin panel, fin tip and the rib /see Figure 3/ using a drill dia. 2.5.
 Also remove the 2 extreme vertical rivets joining the rudder mount fitting and the fin rib using a drill dia. 3 mm.
- 2. Prevent further crack propagation /if the cracks are no longer than 5 mm/ by drilling a 2 mm hole at each end of the crack. Deburr these holes carefully.
- 3. Place two angles items 2 and 3 under the rib, mark the holes for rivets, drill a hole dia. 2.6 mm, recess this hole and then mark and drill the vertical holes according the original holes, using a drill dia. 3.1 mm.
- 4. Deburr the drilled holes thoroughly on both the angles and the fin.
- 5. Install both angles properly and attach by riveting.

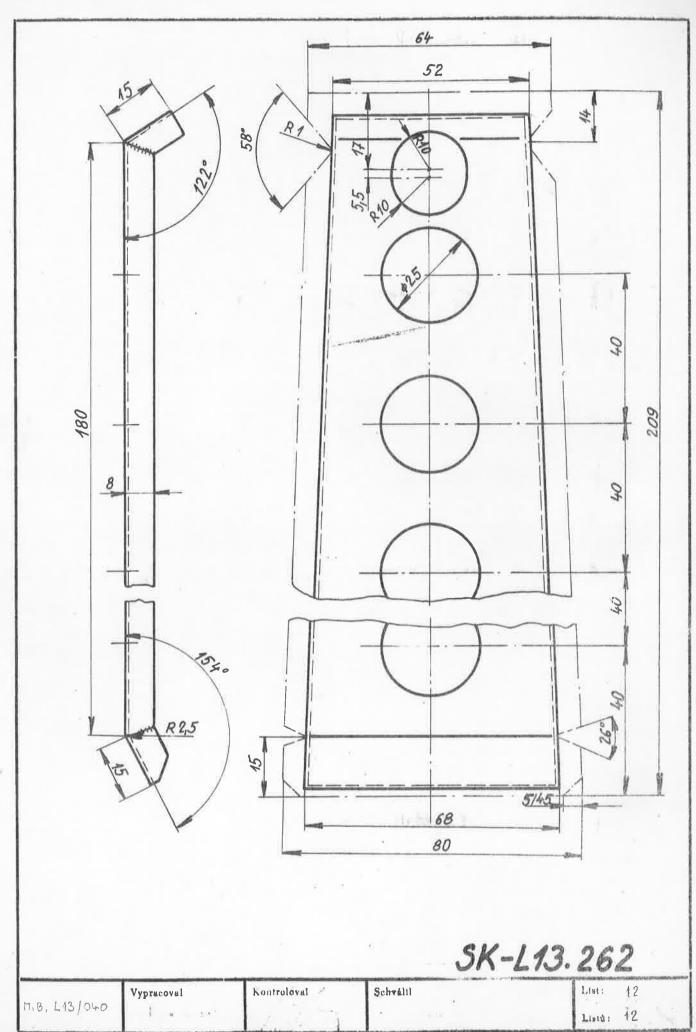
- 2. Swing the fuselage tail cone to check the central stiffener, which is designed to support the bottom mount of rudder /see Figure 2, item 1/, for cracks particularly near to the top edge. In case of crack propagation on this central stiffener as well as in case of a damage to the fin top rib it is necessary to follow the repair instructions as per the paragraph B. Should there appear cracks on the central stiffener with no damage to the fin top rib, the sailplane may continue to be operated subject to performing a repair as per the paragraphs B and D, within the maximum of 100 hours.

- 19. Reinstall all the components and items within the control system in the reversed sequence as listed in items 1 through 17 above. The cables must be properly tensioned in compliance with the Technical Manual, Chapter III.
- 20. Check the deflection angles of both elevator and rudder.
- 21. Check for proper lockwiring of all nuts and turnbuckles.
- 22. Repair or attach the rubber covers on the cockpit floors.
- 23. Enter the above operations performed into the aircraft logbook.
